Instytut Techniczny Wojsk Lotniczych

Selected problems of material testing of damaged compressor disks made of titanium alloys

The object of research - a fourth stage disc of a low pressure compressor

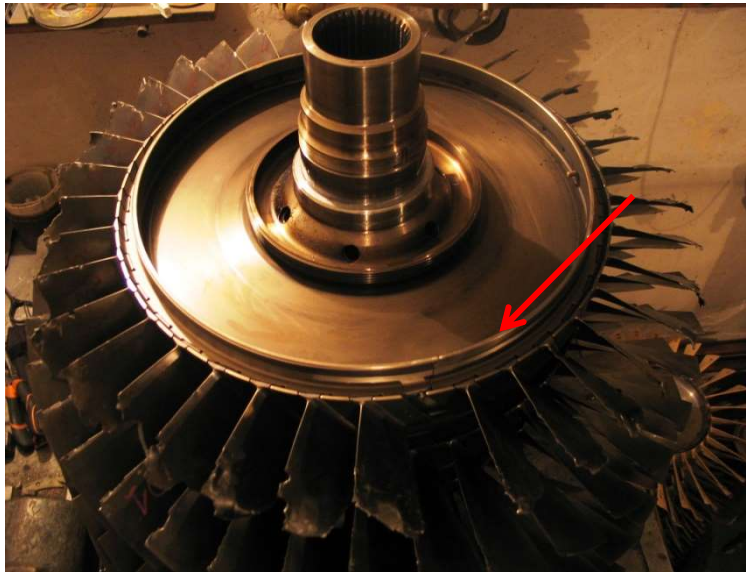
2. The fan impeller of the RD-33 engine with a damaged IV grade disc marked as "1" in the state of delivery for testing, the figure shows a visible crack of the 4th degree disc

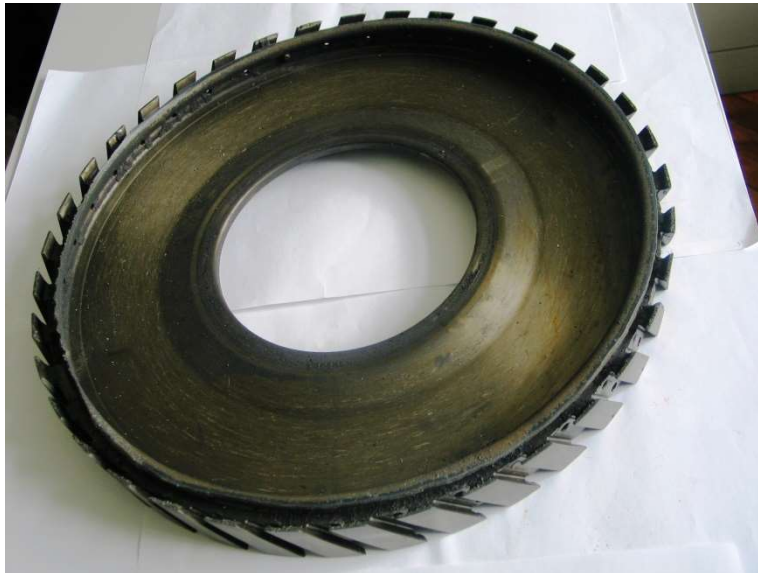
3. The fourth-degree fan of the RD-33 engine fan is marked as "2" in the state of delivery for testing

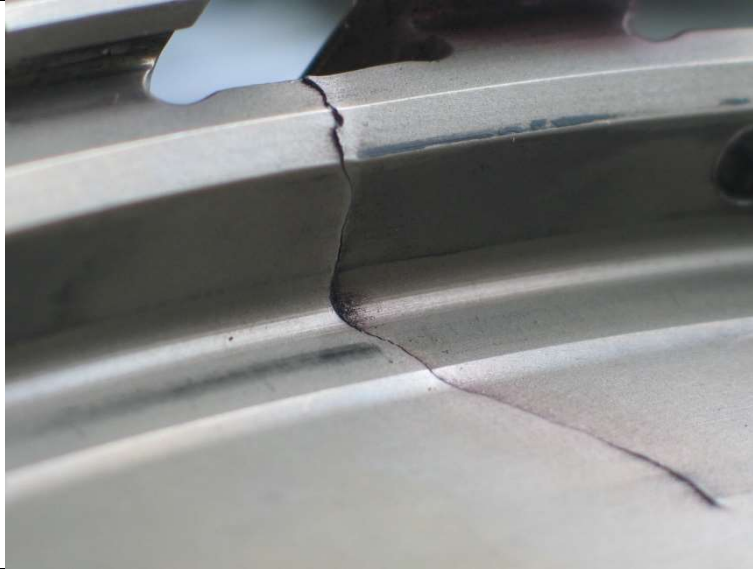
Element	Description of the condition of the item under examination
4th stage low-pressure compressor blade. The area of the vane socket No.	Figure 3. A break in the cross-section of the disc, extending over a length of about 35 mm (counting from the blade collar), propagating from the slot the blade No. 4 along the radius of the blade from the side of the leading edge and the trailing edge of the blades. Zoom 2,3 x.

<p>4. The view from the air intake.</p>

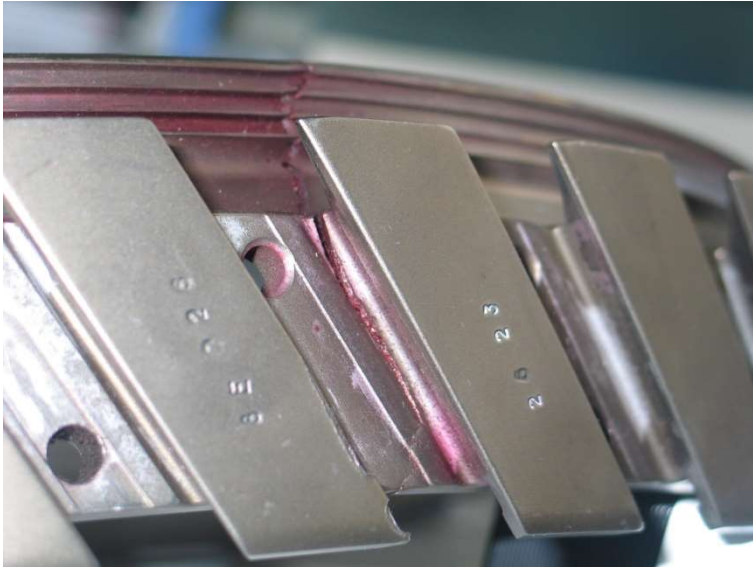
<p>The low-pressure compressor IV shield is marked as "1". The area of the vane socket No. 4. View from the outside of the rotor.</p>	<p>The break of the disc with the displacement running through the entire thickness of the disc flange, propagating from the vane slot No. 4 along the radius of the disc from the side of the leading and trailing edge. The opening of the crack at the edge of the disc is about 1 mm. Zoom 0,6 x.</p>

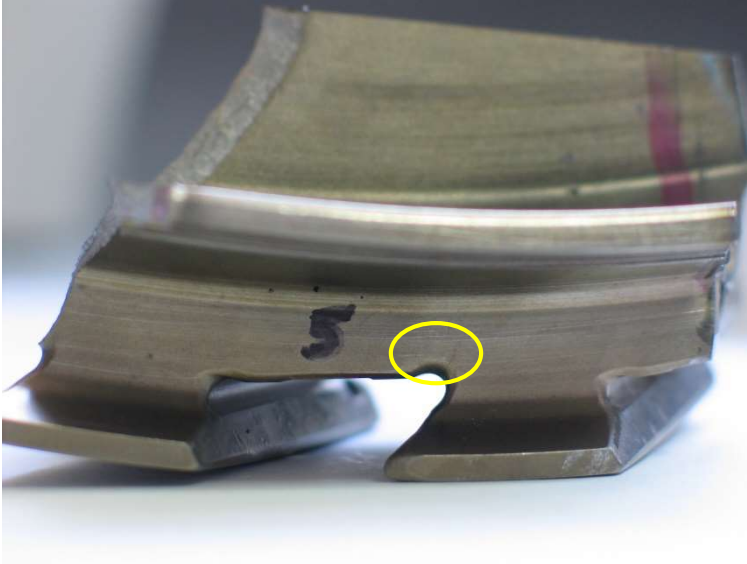
<p>The low-pressure compressor IV shield is marked as "1". The area of the blade seat No. 5. The view from the side of the high-pressure compressor after cutting out the blade fragment.</p>	<p>The crack on the radius of the blade shoulder No. 5, formed from the side of the blade trough. The crack runs on the surface of the disk from the side of the compressor and on its side surface (in the blade seat). The crack has a length of 5 mm from the edge of the disk. During the dismantling, 14 such cracks (length from 1.5 to 7 mm) were identified and verified during non-destructive testing.. Zoom 1,8 x.</p>

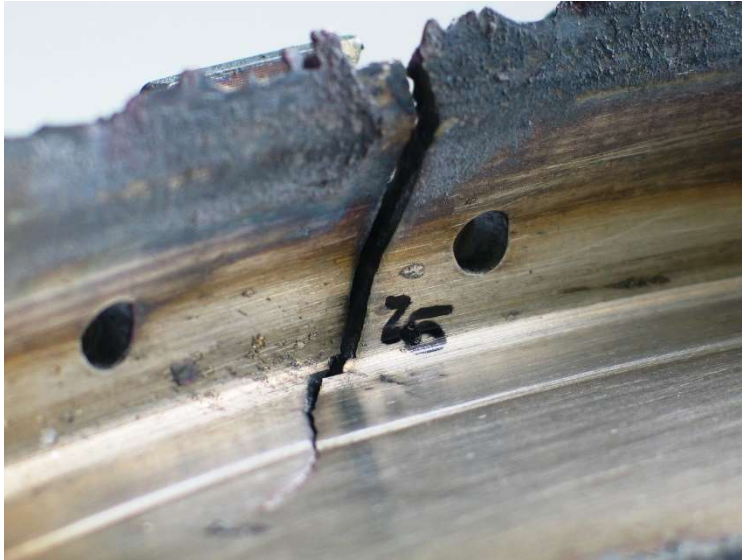
<p>The low-pressure compressor IV shield is marked as "2". The area of the blade seat No. 26. The view from the side of the high-pressure compressor.</p>	<p>A fracture of the dial, running along the length of approx. 35 mm (counting from the blade collar), propagating the blade No. 26 along the blade's radius from the side of the blade trough. View after descaling. Zoom 2 x.</p>

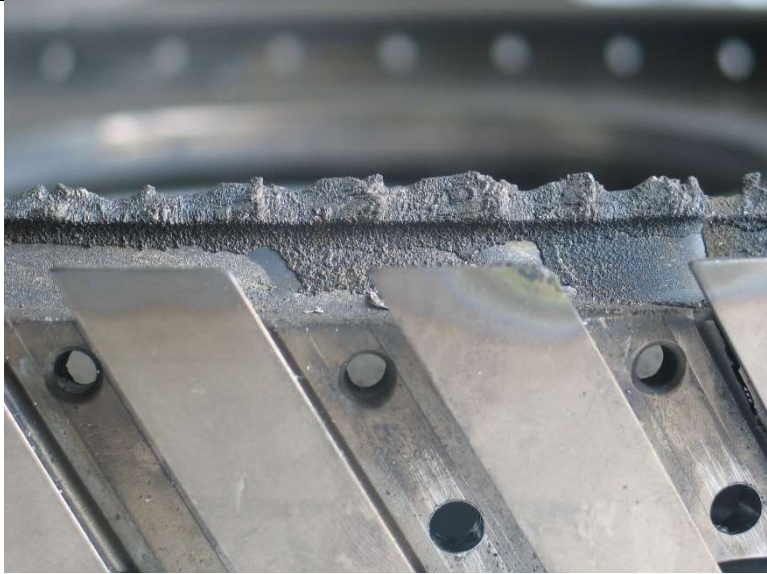
<p>The low-pressure compressor IV shield is marked as "2". The area of the blade seats No. 24, 25 and 26. View from the outside of the rotor.</p>	<p>On the outer surfaces of the fourth-degree scapula pockets, at their upper edges, changes in the color of the nest material from yellow to golden, purple to navy blue are observed as a result of high temperature, besides in about 2/3 of them, the scale is observed. Zoom 1,4 x.</p>

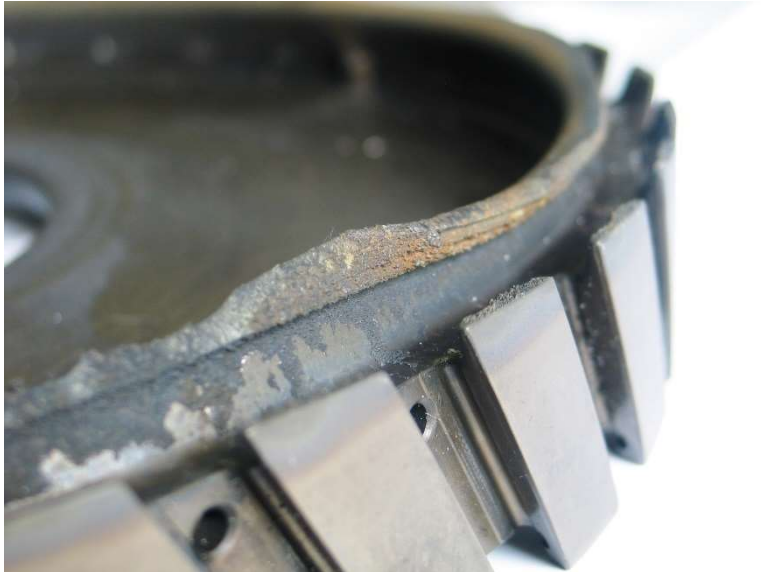
<p>The low-pressure compressor IV shield is marked as "2". View from the outside of the rotor.</p>	<p>There is a strong deformation of shape on the ring of the 4th-degree disc. On the perimeter of the ring, for the length of 10 blade seats (from slot 18 to 28) the edge of the disc has been bent. In addition, significant losses of its material are visible. On the surface of the ring from the side of the high pressure compressor, a very large amount of scale is observed - it covers about 80% of the surface of the ring. Zoom 1,1 x</p>

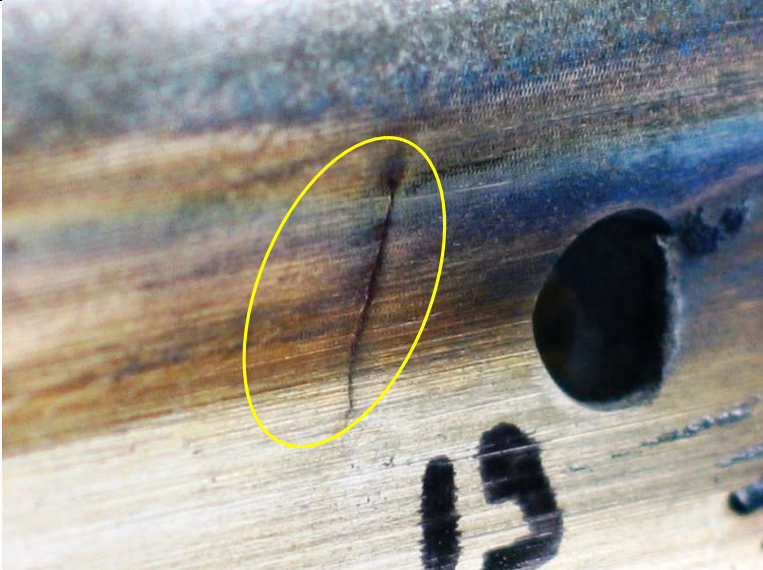
<p>The 4th-degree compressor IV shield is marked as "2". The area of the blade seat No. 19. The view from the side of the high-pressure compressor (from the inner side of the rotor), after cutting out the blade fragment.</p>	<p>The crack on the radius of the blade shoulder No. 19, formed from the side of the blade trough. The crack occurs from the side of the high-pressure compressor and on its side surface (in the blade seat). The crack has a length of 9 mm from the edge of the disc and is a break throughout. Zoom 5,5 x.</p>

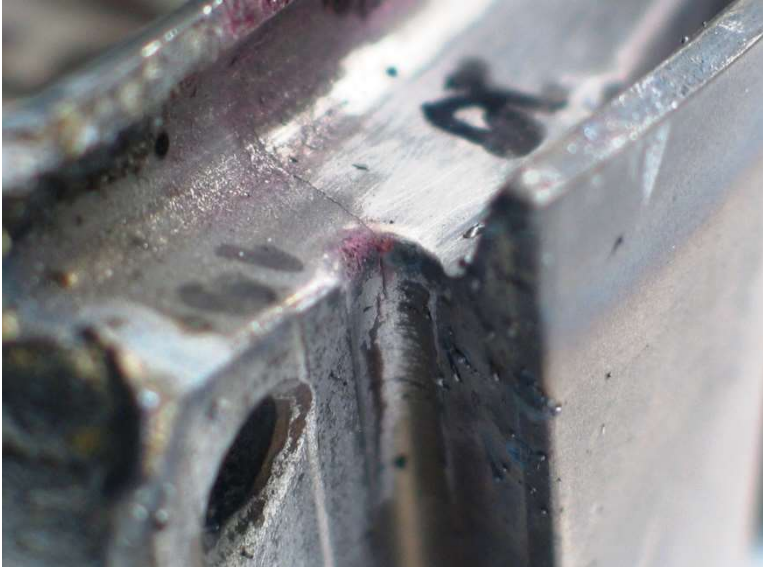
<p>The low-pressure compressor IV shield is marked as "2". The area of the blade seat No. 29. View from the side of the high-pressure compressor after cutting out the blade fragment.</p>	<p>The crack on the radius of the blade shoulder No. 29, formed from the side of the blade trough. The crack runs on the surface of the disk from the side of the compressor and on its side surface (in the blade seat). The crack was observed after cleaning the scale disc during the preparation of the non-destructive testing target, such as 22 similar cracks (with an approximate length of 1.5 to 10 mm). Their verification will be carried out during non-destructive testing. Zoom 2,5 x.</p>

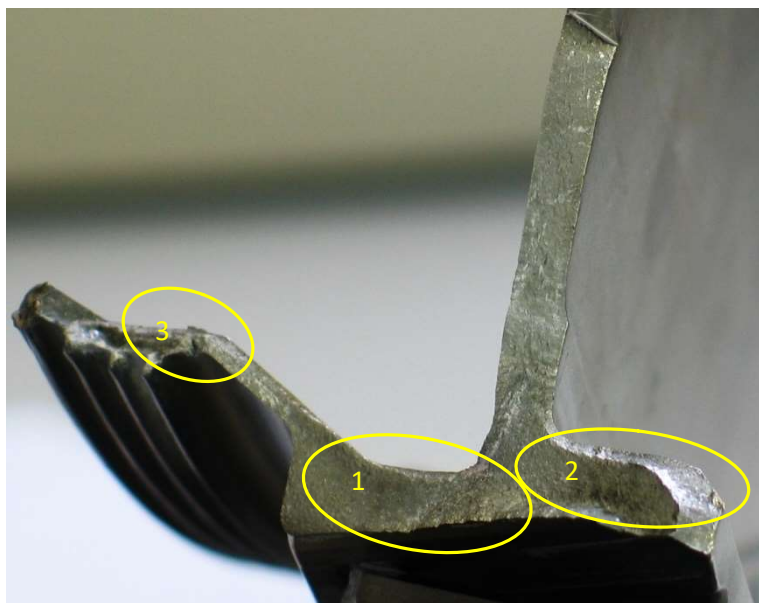
Figure 4 shows the macro construction of the fourth stage disc scrap in the blade seat No. 4 in the area marked as "1". During the tests, three scrap zones with a characteristic

design and color were found. The first of them is a region with a characteristic shell shape at the outer surface of the shield - the focal zone. The area of scrap in this zone is golden-yellow. The second one is a zone of crack growth characterized by small surface roughness and its gray color. The construction of scrap in both above-mentioned zones shows macroscopic features of fatigue cracking. The third zone is the dugout (zone with the largest surface roughness). The change of color in the focal zone of this region - "1" of the shield scrap "1" in the blade seat No. 4 and the construction of this scrap area suggest that this scrap fragment originated earlier than the others, where no color changes were observed. Figure 5 shows the macro construction of the fourth-degree shield scrap marked as "2" in the blade seat No. 26 ". During the tests, three scrap zones with a characteristic structure were found. The first of them is a region with a characteristic shell shape at the outer surface of the shield flange - the focal zone. The second one is a zone of crack growth characterized by small surface roughness. The construction of scrap in both above-mentioned zones shows macroscopic features of fatigue cracking. The third zone is the dugout (zone with the largest surface roughness).

4. Macro construction scrap of the 4th-degree disc marked as "1" in the blade seat No. 4 with marked characteristic areas of scrap description in the text

The source of loads of the rotor fan wheel IV of the RD-33 motor in the discussed area is circumferential stresses resulting from the method of mounting the disc ("push-in") and vibration of the blade in the disc slot. In addition, the area described is the area of the notch bottom. As a result of the conducted tests, it is estimated that the fatigue centers in the scrap regions marked as "1" were the initiation places for cracking both discussed IV discs in blade seat No. 4 for disc "1" and blade seat 26 for disc "2". The cracks of the discussed IV rotor discs started the process of destroying the RD-33 engines, on which they worked.

The primary damage to both tested rotor IV degree discs of the RD-33 engine fans was their fatigue cracking, initiated in the area of the blade seat No. 4 in the case of the shield marked "1" and in the area of the blade seat No. 26 in the case of the disk marked "2".

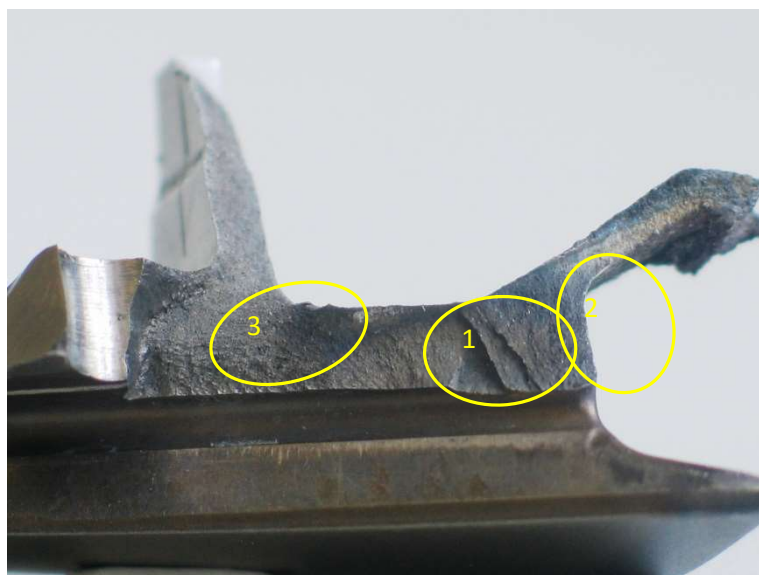
5. Macro construction scrap of the fourth-degree disc marked as "2" in the blade seat No. 26 with marked characteristic areas of scrap description in the text

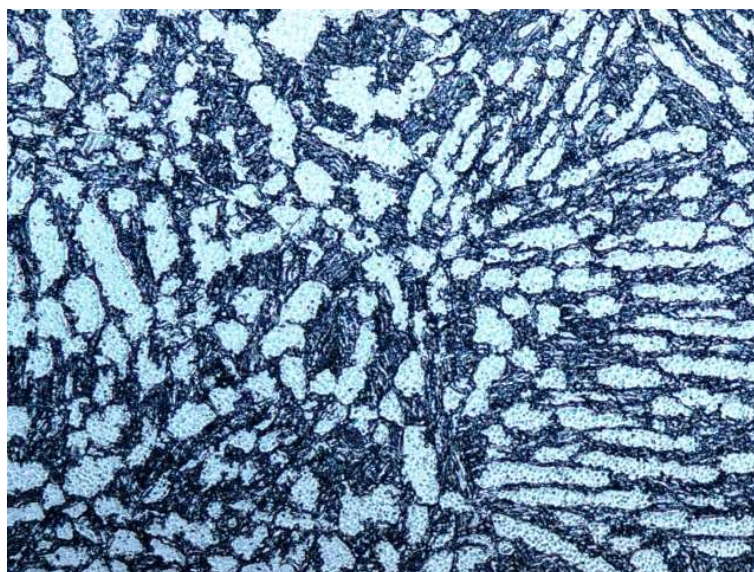
Observation of the structure was carried out on metalized metallographic cuts prepared for this purpose. The observations show that the structure of the material of both examined discs IV stage of the fan rotor in the core is a two-phase, oriented $\alpha + \beta$ plate and globular-plate structure with various degrees of dispersion of α phase plates (see Fig. 6). The fan rotor IV wheels are made of two-phase titanium alloy WT9, belonging to the group of martensitic alloys $\alpha + \beta$. WT9 alloy is a heat-resistant alloy designed for plastic working, based on the Ti-Al-Mo Zr-Si system [1]. The structure shown in Figure 6 is suitable for the WT9 titanium alloy.

6. Grated 1/36 / 14-2 grinding - axial section through the low-pressure compressor stage IV disc designated as "1", away from the crack initiation points and the damage observed. Image of material microstructure, characteristic for both tested disks for areas located far from the damage.

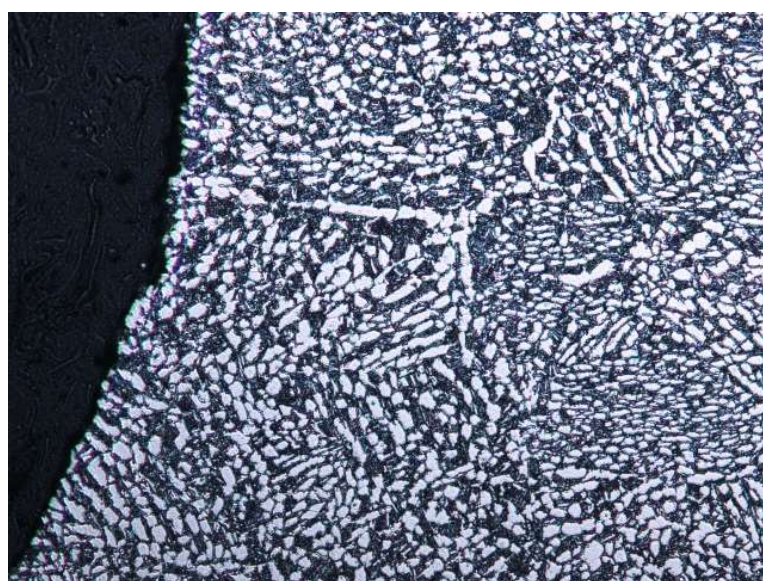
Figure 7 shows the structure of the shield material IV marked as "1" in the blade seat No. 4, in the vicinity of the scrap metal marked as "1", in the bump zone, at the edge of the sample. During the research, no defects or structural heterogeneities were found that could contribute to the destruction of the target. In the case of disc "2", there were also no defects and structural non-homogeneities of the material in the blade seat No. 26, in the area of scrap metal.

7. Grinded cut 1/36 / 14-5 - cross-section perpendicular to the surface of scrap in the region marked as "1", in slot No. 4 of the shield "1". Image of the microstructure in the nasal zone characteristic for both examined discs.
