**Piotr Mackiewicz**

**Eryk Mączka**

**Drone usage for pavement damage identification**

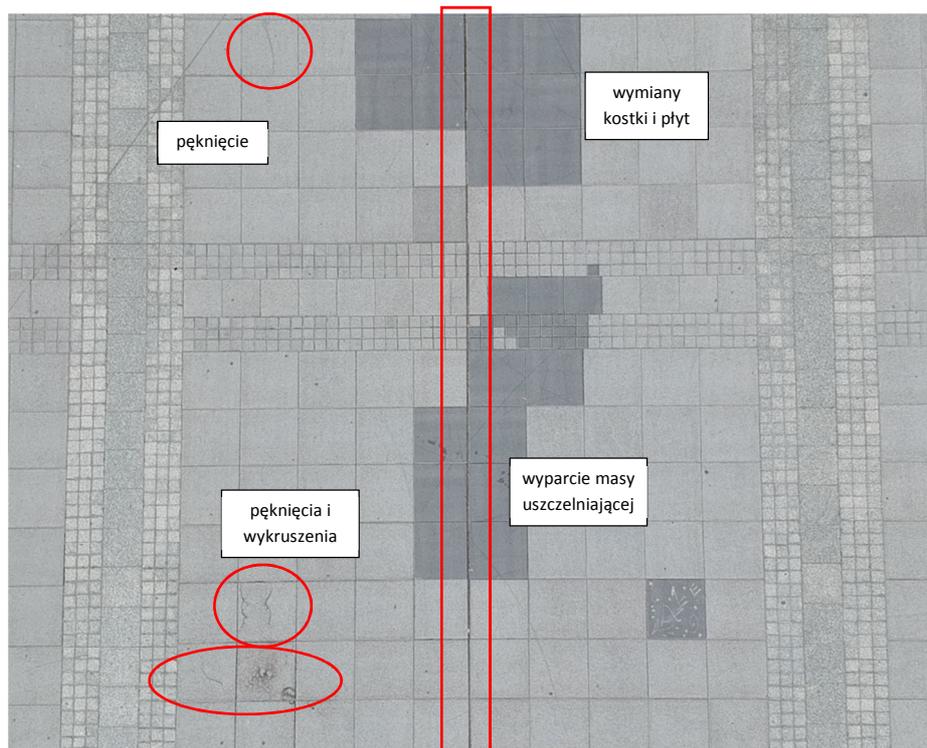
5. Photo of an identified damages of the registered square

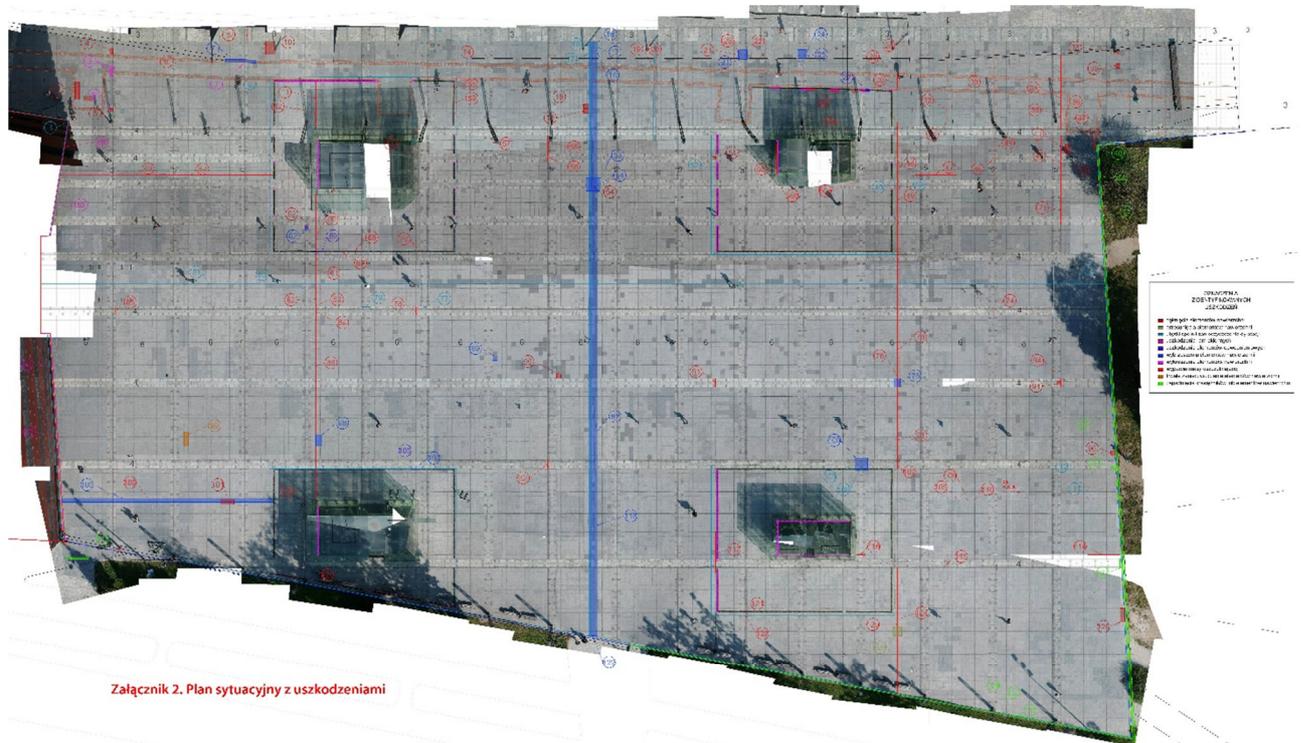
9. Site plan of the entire square with damages

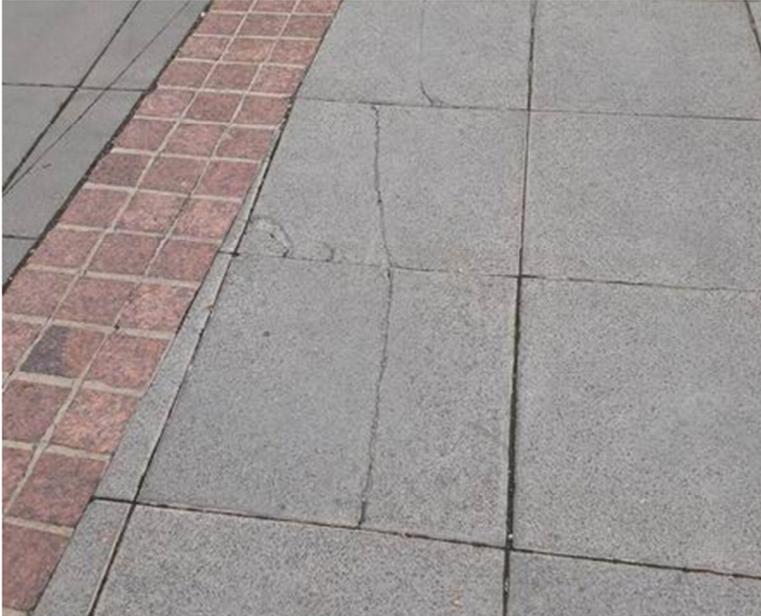
10. Examples of panel cracks (in the middle and on the edge)

Some cracks in the pavement elements are wider than 3 mm and pose a risk of chipping from the pavement, which may pose a threat to pedestrian traffic. The identified shifts of the surface (slabs) are an unsightly visual element, as are stains and other color changes. More important are several-centimeter deformations of the curbs, which may affect the pollution of the square and water outflows.

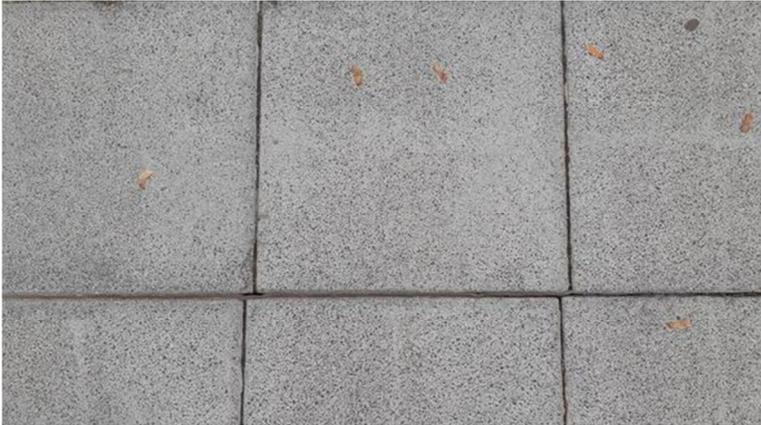
11. An example of shifting pavement elements

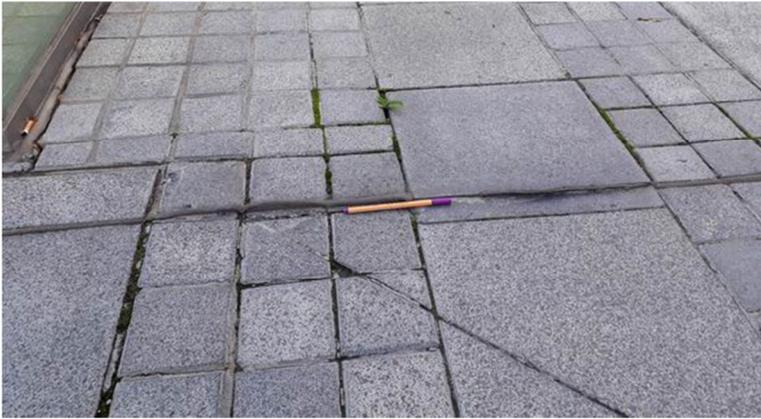
12. Examples of sealing mass displacement

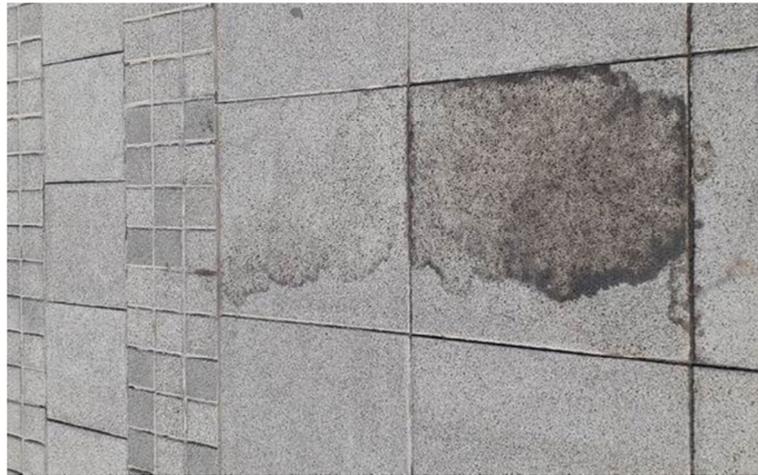
**13.** Examples of permanent contamination of pavement elements

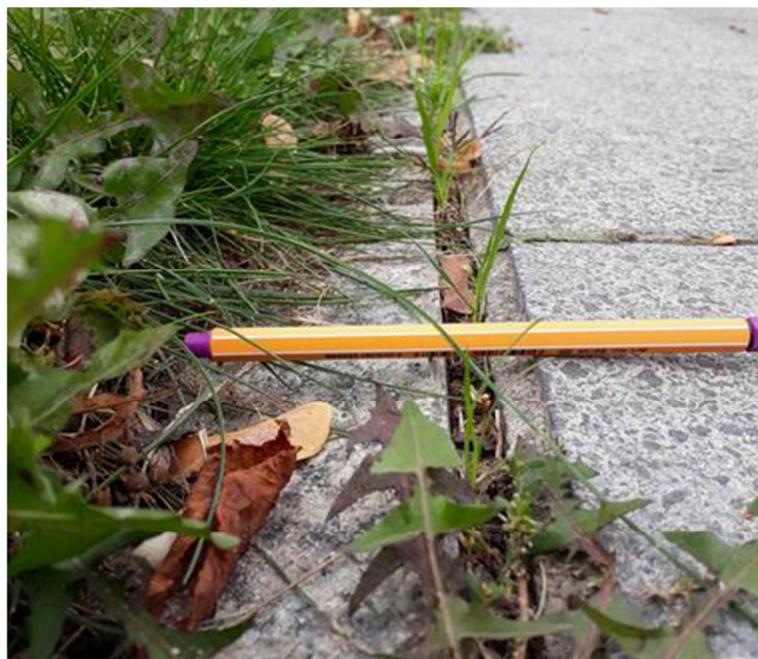
**14.** Examples of curb collapses/shifts

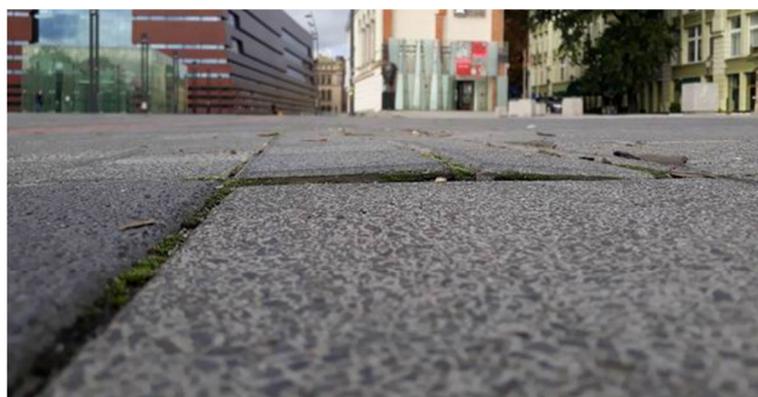
**15.** An example of the bulge of pavement elements

It was found that the identified damages are primarily a consequence of thermal impacts (limited movement of small-sized elements), and partly the impact of vehicles. The global analysis of the area using drone images indicated three distinct mass bulges/extrusions

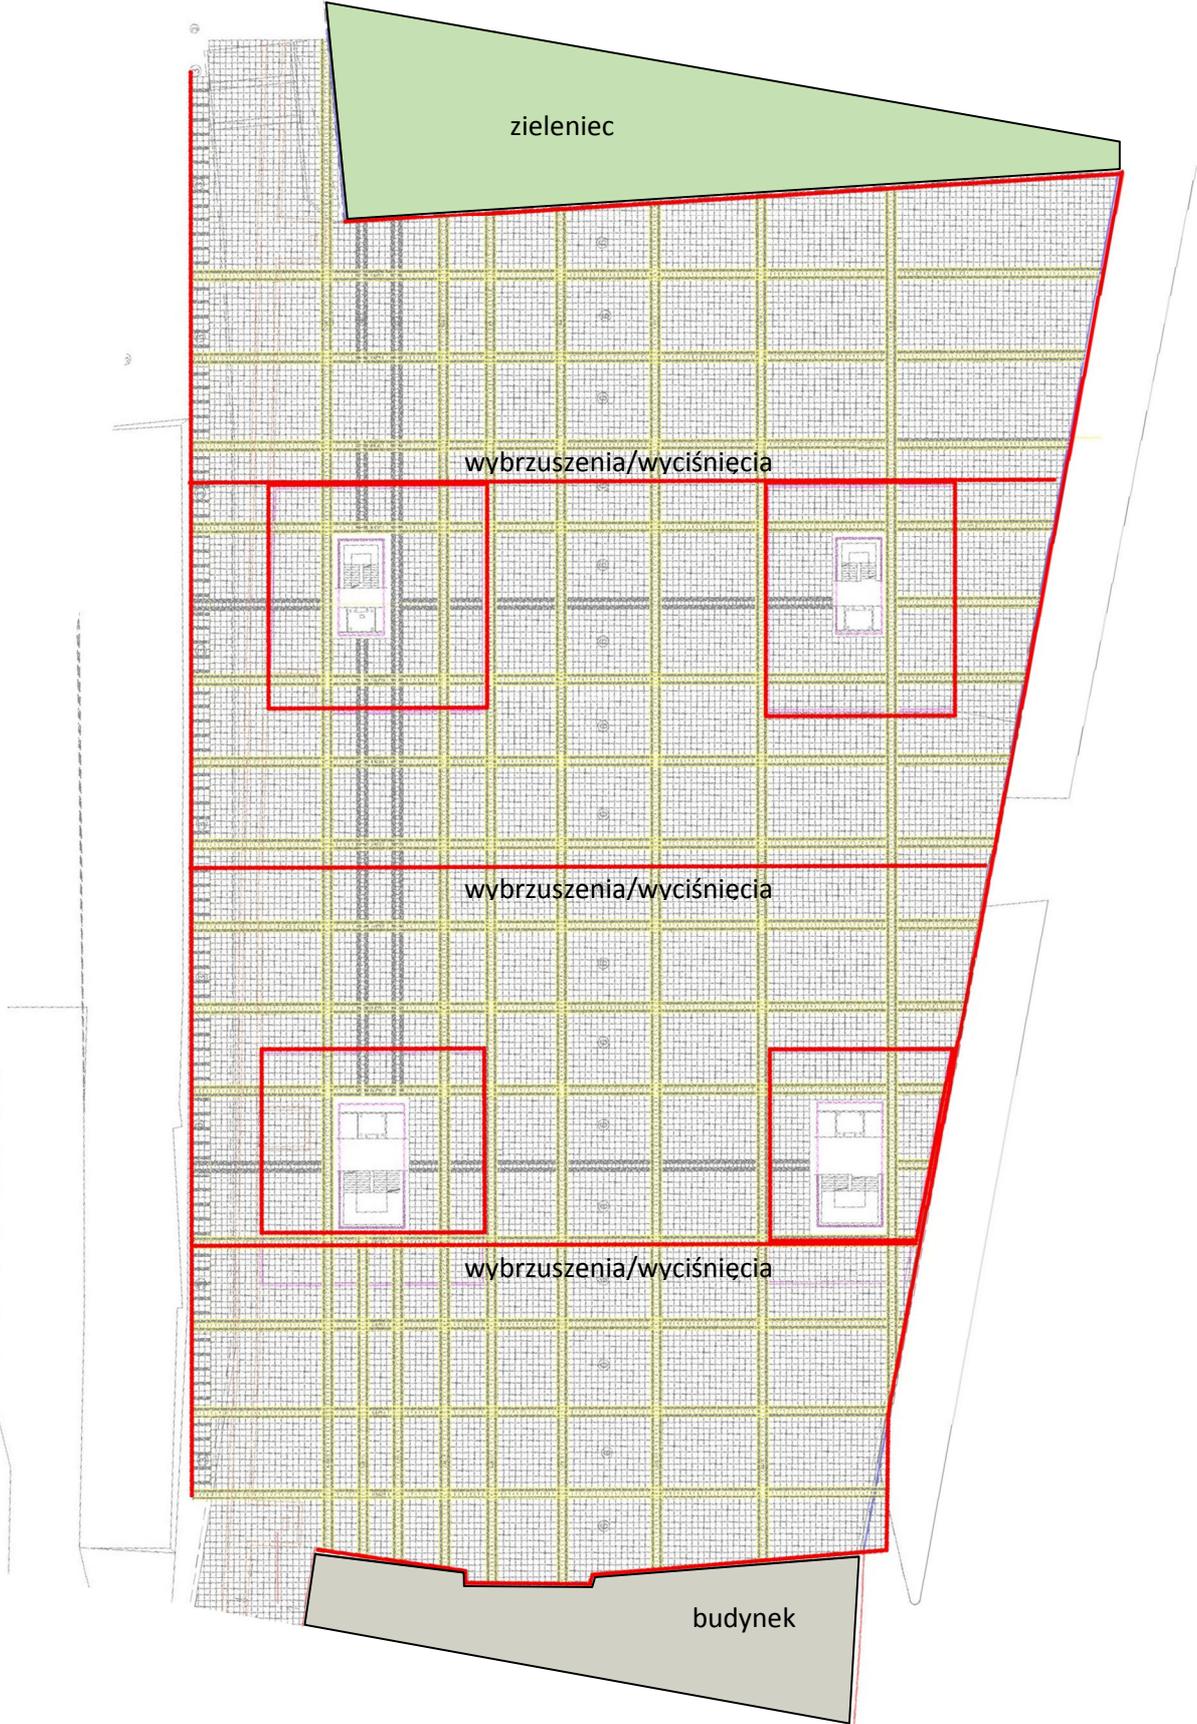
(1-3 cm), which were determined based on global damage identification (Figure 16). It should be noted that the entire area of the square is currently "divided" into four slabs (approximately 40 m wide), limited on the one hand by the impact on the building (directly on the window frames), and on the other by the curb (which has been moved into the green area). The consequence of significant displacements of up to several centimeters is the pressing of the mass from the cracks or its crumbling. Damage to the joints may cause further degradation of the lower layers as a result of water penetration into the pavement.

The method of using a drone to take pictures and capture video was undoubtedly helpful in assessing the causes of damage to the square. The pavement made of concrete slabs lacked appropriate technological solutions. The cause of the described thermal damage is the over-stiffening of the constructed structure and the ratio of the thickness of the expansion joints to their dimensions in the plan is not maintained. As a result of too large spacing of expansion joints, or practically the lack of them, the critical length of the slab was exceeded and the space for its movement was limited.

16. The area of the square is divided into areas as a result of thermal influences
