Piotr Mackiewicz

Antoni Szydło

Analysis of the impact of concrete pavement finishing technologies on selected exploitation traits

Abstract: We studied various technologies of finishing the upper layers of the concrete pavements. The analyses were made on the basis of own research on selected sections of motorway and express roads with a concrete surface in Poland. On this basis, the variability of equality and texture was determined depending on different types of structures, finishing methods and operational periods. It was found that the change of construction technology and the type of construction significantly influence the change of equality, while the technology of finishing the upper surface influences the texture. The best equality was obtained for the non-dilatation pavements with continuous reinforcement. It was shown that the texture indicator is strongly dependent on the pavement exploitation. In addition, an assessment of the impact of equality and texture on the noise level in the vehicle's cabin was carried out.

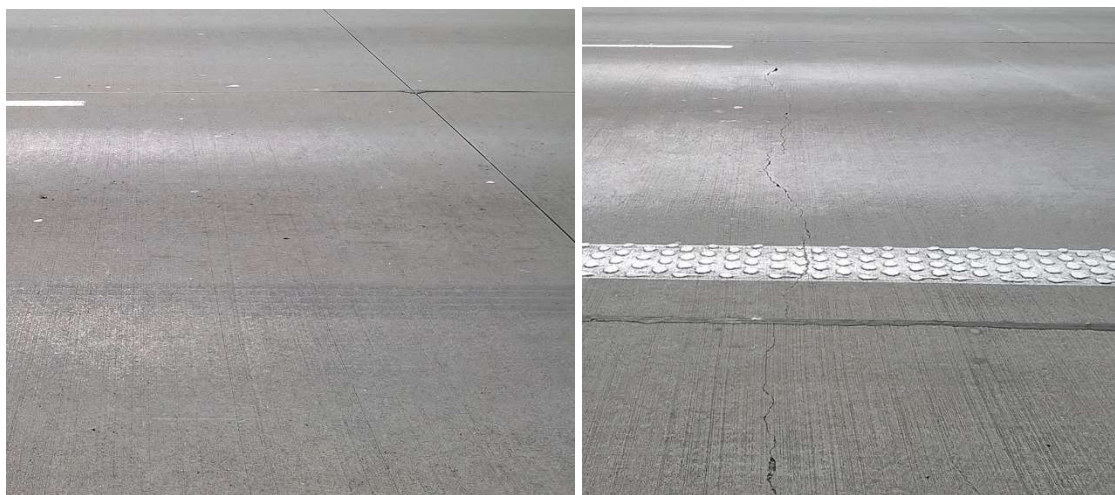
3. The A4 motorway - paved surface (left) and continuous reinforcement (on the right)

In terms of the section of the A4 motorway (km 132 + 500 - 137 + 000), different types of concrete surfaces were tested: paved surface (with transverse gaps) on the foundation of aggregate, surface with continuous reinforcement (without transverse gaps), paved surface (with transverse gaps) on the foundation of lean concrete. The northern carriageway was commissioned in 2005, and the southern carriageway in 2000. The transverse gaps were filled with profiles. The upper surface of the surface has been finished with transverse brushing (Fig. 3).

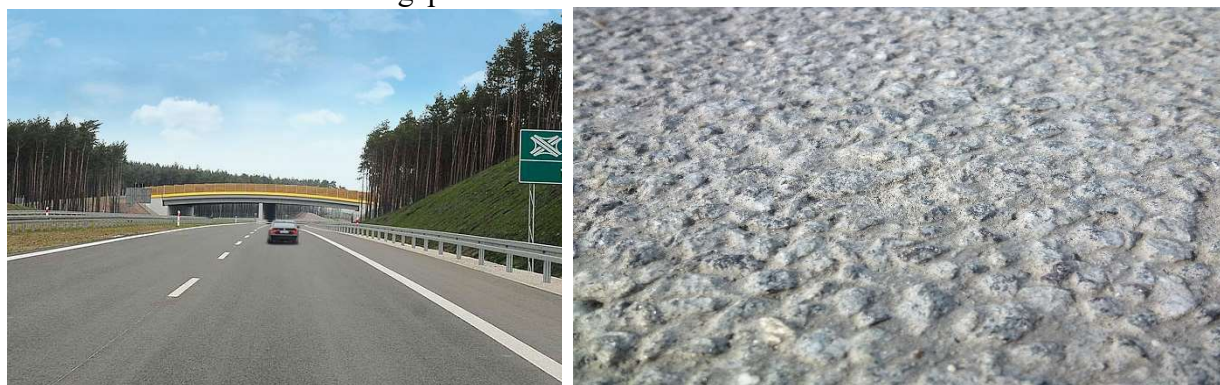
4. The S8 expressway - "discovered aggregate" technology

On the S8 expressway (the year of putting into operation 2015), the surface of the aggregate technology was analyzed on a section of eight kilometers (Figure 4). The pavement is made of concrete slabs with transverse gaps on the foundation of lean concrete.

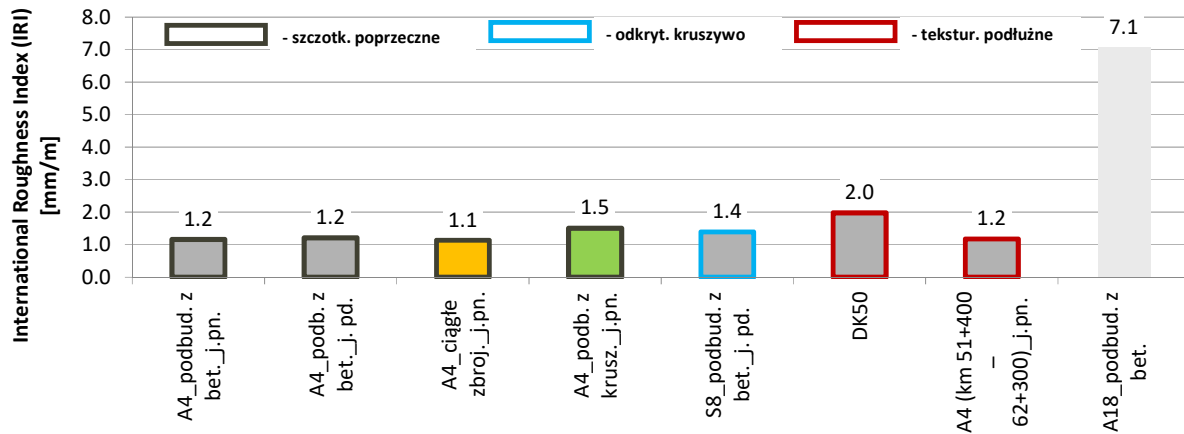
5. Comparative results of IRI index values

Fig. 5 presents the results of measurements of the IRI indicator value on the tested sections of concrete pavement.

On the basis of a comparative analysis of different types of surface, it was found that the surface with continuous reinforcement has the lowest IRI value. Other surfaces also have relatively low values and are located in class A according to DSN, with the exception of the DK50 road (approaching the B class) and the exploited A18 road in class D. The structure on the aggregate foundation with IRI = 1.5 is also slightly different. mm/m. In the case of the indicator responsible for texture (MPD), greater variation was found (Figure 6). However, it is not dictated by the type of construction, finishing technology and period of use.

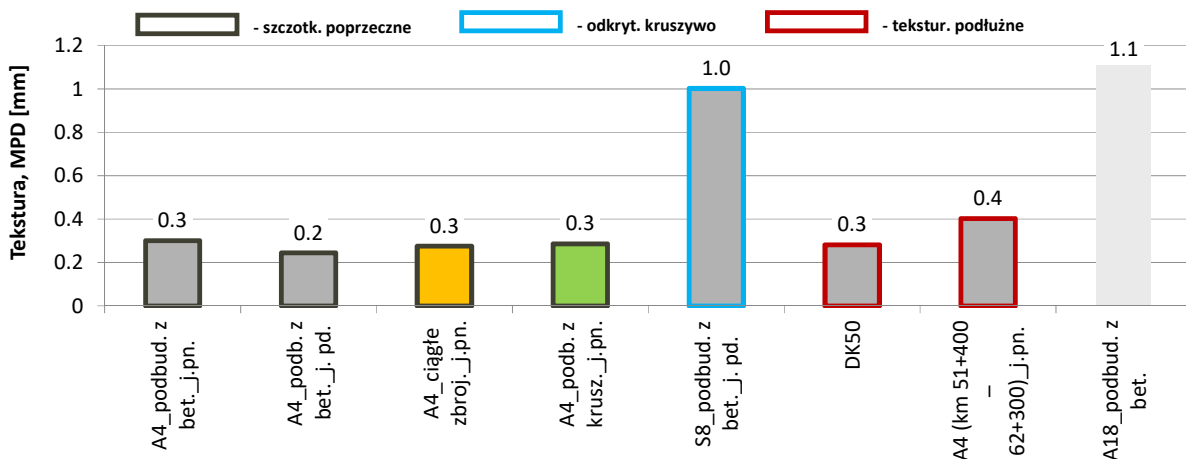
6. Comparative results of the MPD indicator values

It is worth noting that in one group of results there are surfaces of the A4 motorway with the texture of transverse brushing and the section of the A4 motorway (km 51 + 400 - 62 + 300) and DK50 made in longitudinal texturing (towed jute). In the second group, there are S8 surfaces made in the "discovered aggregate" technology. Large MPD values can be attributed to appropriate finishing technology and a relatively young, two-year service life. The smallest MPD values were obtained on over 15 years of A4, on which transverse

brushing (about 0.2 mm) was used on the surface. Slightly larger for a longitudinal texture (about 0.4 mm). An exceptionally high texture index occurs on the old A18, which is dictated by the damaged surface structure and numerous crushed aggregate and grout grains.

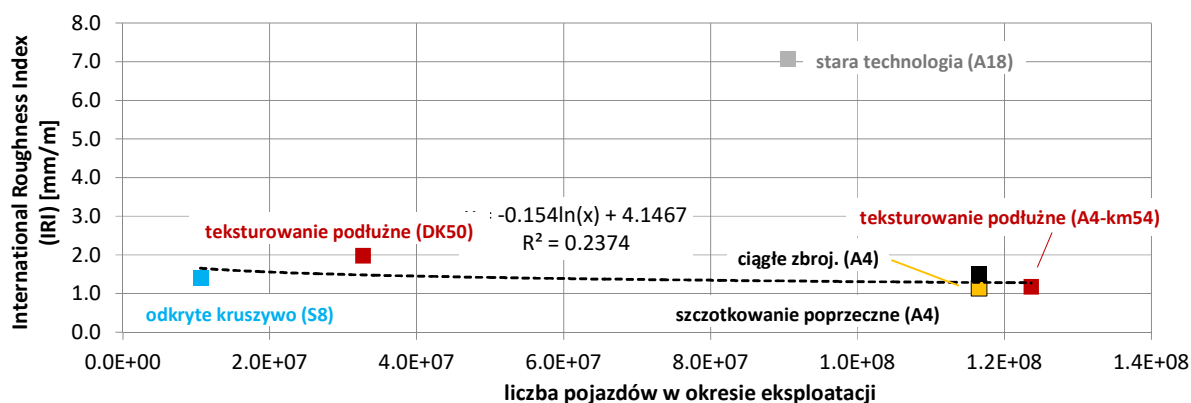
7. Changes in the IRI texture indicator depending on the number of vehicles in service

At the same time, it should be noted that the tested surfaces have different delivery periods. A4 j. north - 2005, A4 j. south - 2000, S8 - 2015. Changes of the IRI index and MPD textures depending on the number of vehicles in service are shown in Figures 7 and 8, respectively (indicative results for A18 are included).

It is worth noting that much greater variation occurs for the change in the MPD indicator. Surfaces with a longer service life and/or finished in old texturing technology have a "worse" texture. On surfaces made with the "discovered aggregates" technology, almost four times higher MPD texture values are obtained compared to transverse brushing. The texture made in the technology of transverse brushing (from a dozen or so years ago) quickly deteriorated, definitely more than longitudinal texturing with the use of jute mat (20 years of operation), which shows a constant level of 0.3 - 0.4 mm. Of course, the differences can also be associated with a significantly different traffic volume, an accuracy of execution, type of material (concrete, aggregates).

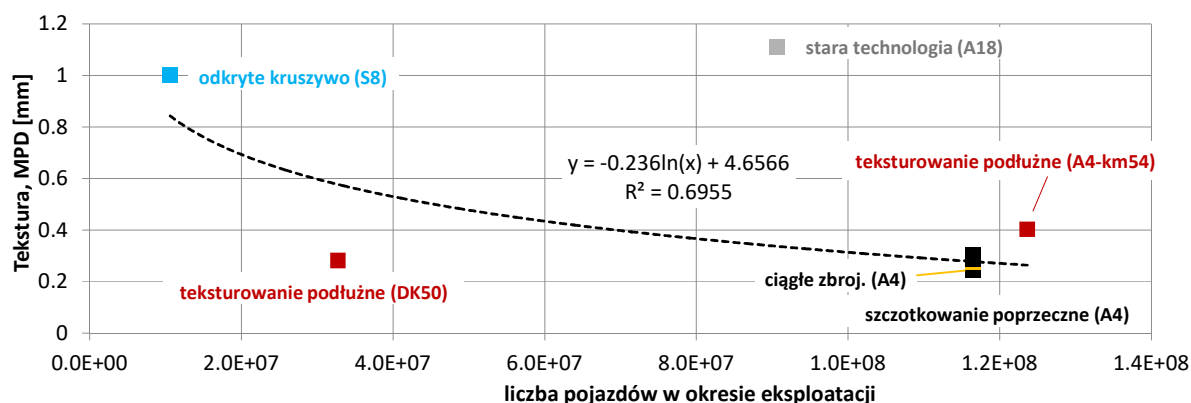
8. Changes in the MPD texture indicator depending on the number of vehicles in service

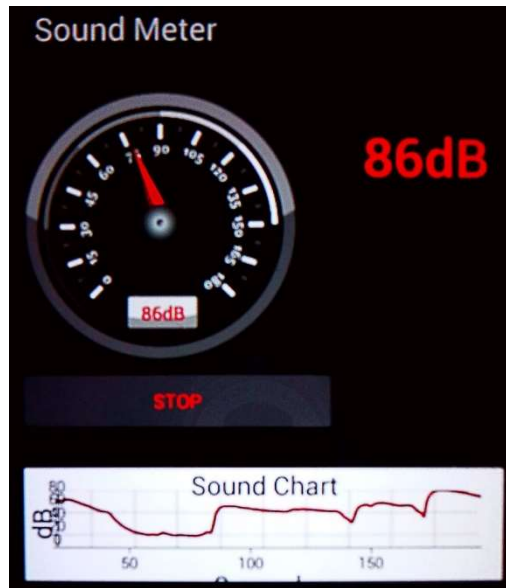
9. The Sound Meter mobile application

Using the Sound Meter mobile application (Fig. 9), sound level measurements were carried out in the cab of a petrol vehicle (Opel Astra). Measurements were carried out on A4, S8, DK50 and A18 roads, on sections where equality and texture measurements were carried out.

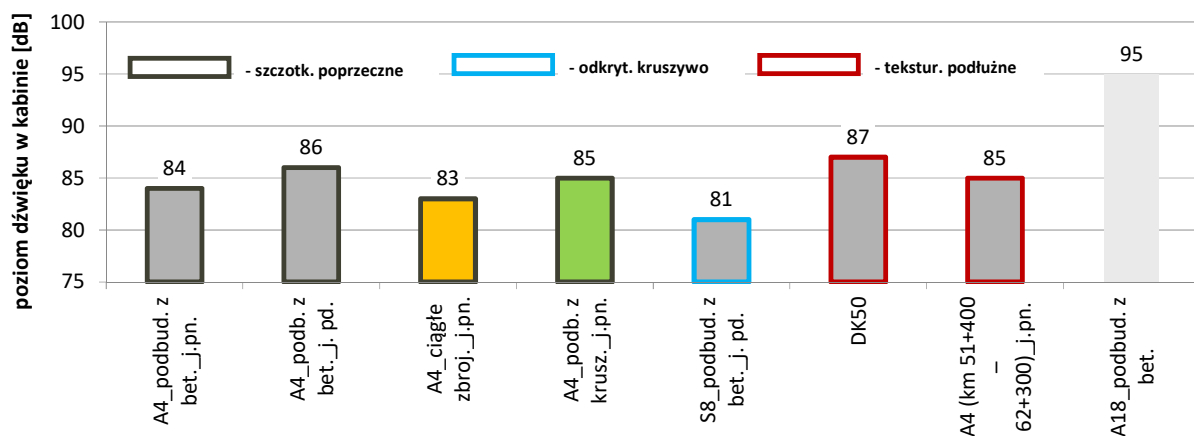
10. Comparative results of the sound level in the vehicle's cabin

Fig. 10 presents the results of measurements of the sound level value in the vehicle cabin on the tested sections of the concrete road pavement.

The lowest sound levels were recorded on the surface with continuous reinforcement (A4) and on the surface of the S8 road made in the technology of the outdoor aggregate. The recorded sound levels of these surfaces are lower by about 3 - 6 dB compared to other surfaces that have dilatation and finish in the form of transverse or longitudinal brushing. Extremely high sound levels were recorded at A18 (95 dB). During the measurements, a vibration of various vehicle components was additionally audible. Sound measurements were carried out at a speed of 100 km/h. At higher speeds, the vehicle's air resistance had a decisive influence on noise.

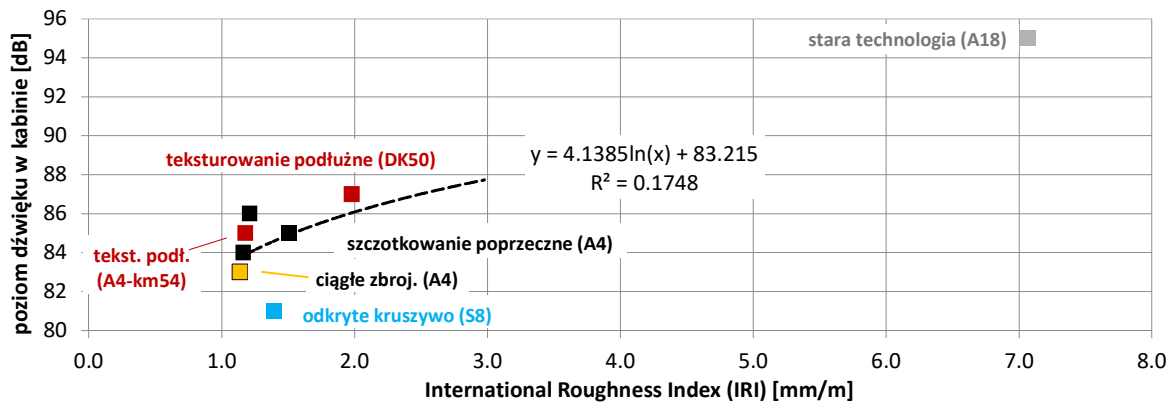
11. Correlation of the IRI indicator with the sound level in the vehicle's cabin

Further analyzes were made on the comparison of the sound level measurement results against the IRI indicator (Figure 11) and the texture of the MPD (Figure 12).

Relatively good correlations were found (especially for the MPD texture) indicating a significant impact of both the type of construction and the finishing technology on the sound level. In the case of pavement with expansion joints, and particularly heavily worn out, the value of the IRI index exceeding the value of 2 mm / m corresponding to class B according to DSN increases. If the MPD texture indicator increases, the sound level in the vehicle cabin decreases. Surfaces finished in the technology of the outdoor aggregate having the texture class A according to the DSN, are able to achieve a lower sound level by about 5 dB compared to the classic technologies of transverse brushing. Noteworthy is also the surface of continuous reinforcement, which, despite the use of transverse brushing and low-class texture (class D) also exhibits low sound levels.

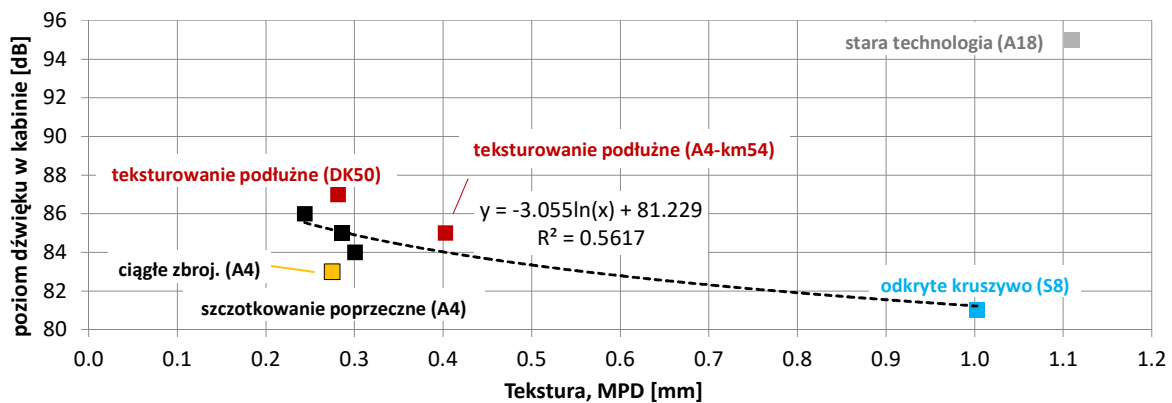
12. Correlation of the MPD indicator with the sound level in the vehicle cabin

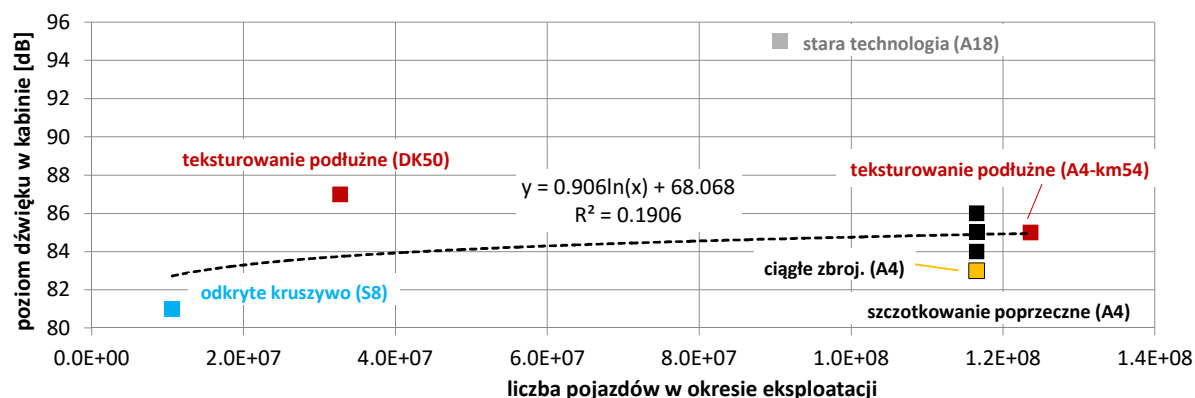
13. Correlation between the number of vehicles in service with the sound level in the vehicle cabin

A certain explanation of these relationships may be the correlation of the sound level in the vehicle cabin with the number of vehicles during the lifetime of the test surfaces (Figure 13).

Together with the increase in the number of vehicles (service life), an increase in the sound level by approximately 2 dB/100 million vehicles is expected.
