Examples of the use of GPR for research at airports

Abstract: The GPR tests were carried out for the needs of the expansion of the "Fryderyk Chopin" airport in Okęcie in Warsaw. There were old and new surfaces at the airport. GPR profiling was conducted on selected lines. For the purposes of the research, core drillings and ground core drillings were performed in the airport pavements. The geological interpretation of the GPR data was made on the basis of drilling data. 6 GPR models were developed for the tested airport pavements. The results of each GPR cross-sectional line were compared with the results of the HWD study. It was found that the use of the non-destructive GPR method for monitoring airport pavements causes: reduction of the number of drilling in pavements, minimization of interruptions in aircraft traffic, quick and effective monitoring of the condition of airport pavements.

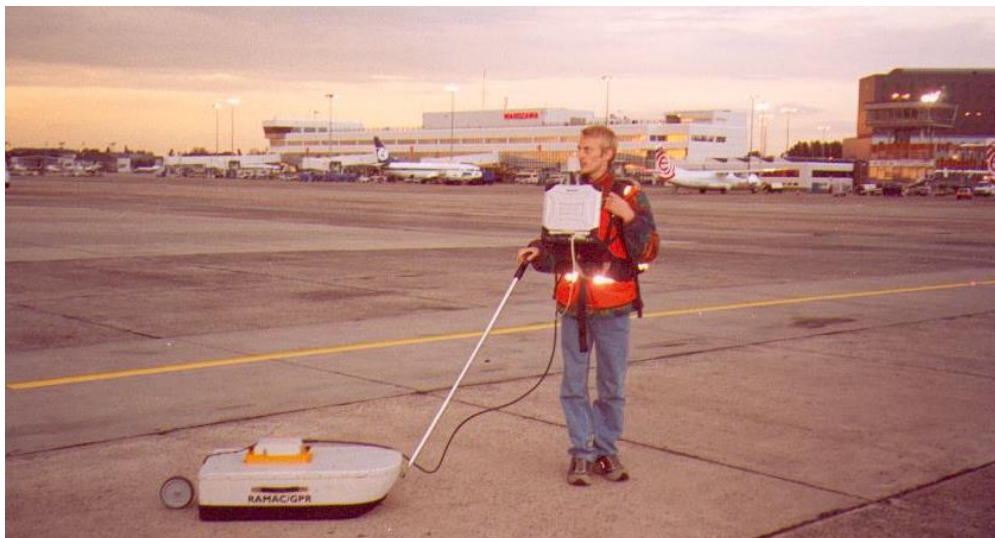
1. RAMAC/GPR equipment with 250 MHz shielded antennas

The GPR method is used to monitor the surface at airports: runways, taxiways, turning pads, aircraft parking pads (APRONS- aircraft parking pads). Methodical, GPR research was carried out for the needs of the expansion of the "Fryderyk Chopin" airport in Okęcie in Warsaw. GPR tests using the linear profiling method were performed to a depth of 2.5 m with the use of RAMAC/GPR with shielded 250 MHz antennas.

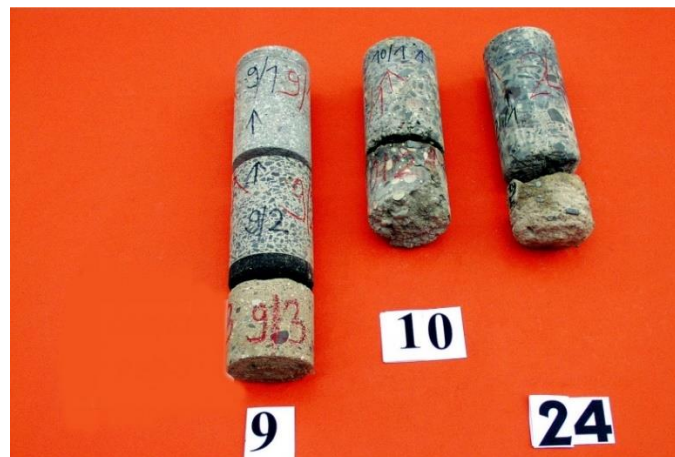
2. Examples of cores from drilling in pavements: 9 - core from the new pavement, 10, 24 cores from old pavement

For over 50 years of the airport's operation, the pavements were rebuilt. There were old and new surfaces at the airport. Drilling has shown that old surfaces are usually one layer of concrete on the so-called base, which was made of a layer of gravel bonded with cement. The new surfaces had two concrete layers lying on a thin layer of asphalt, under which there was a base layer (gravel bonded with cement). The pavements of the taxiways were constructed differently. Most often, the surface layer was made of a layer of asphalt, underneath it there were one or two layers of concrete lying on the base (a layer of gravel bonded with cement).

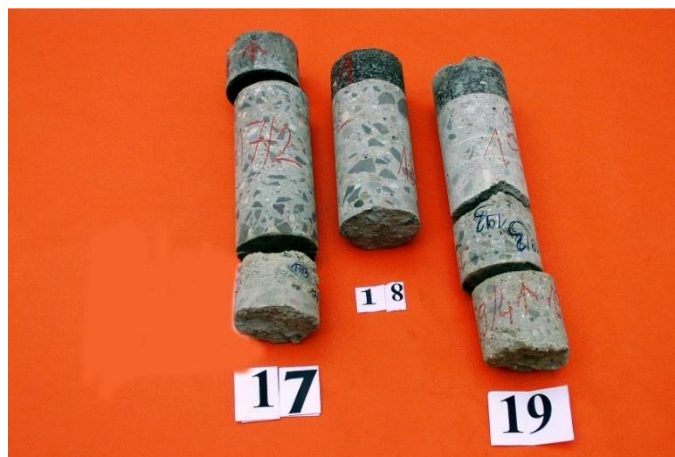
3. Examples of cores from drilling in the Taxiway DK-A4 surface

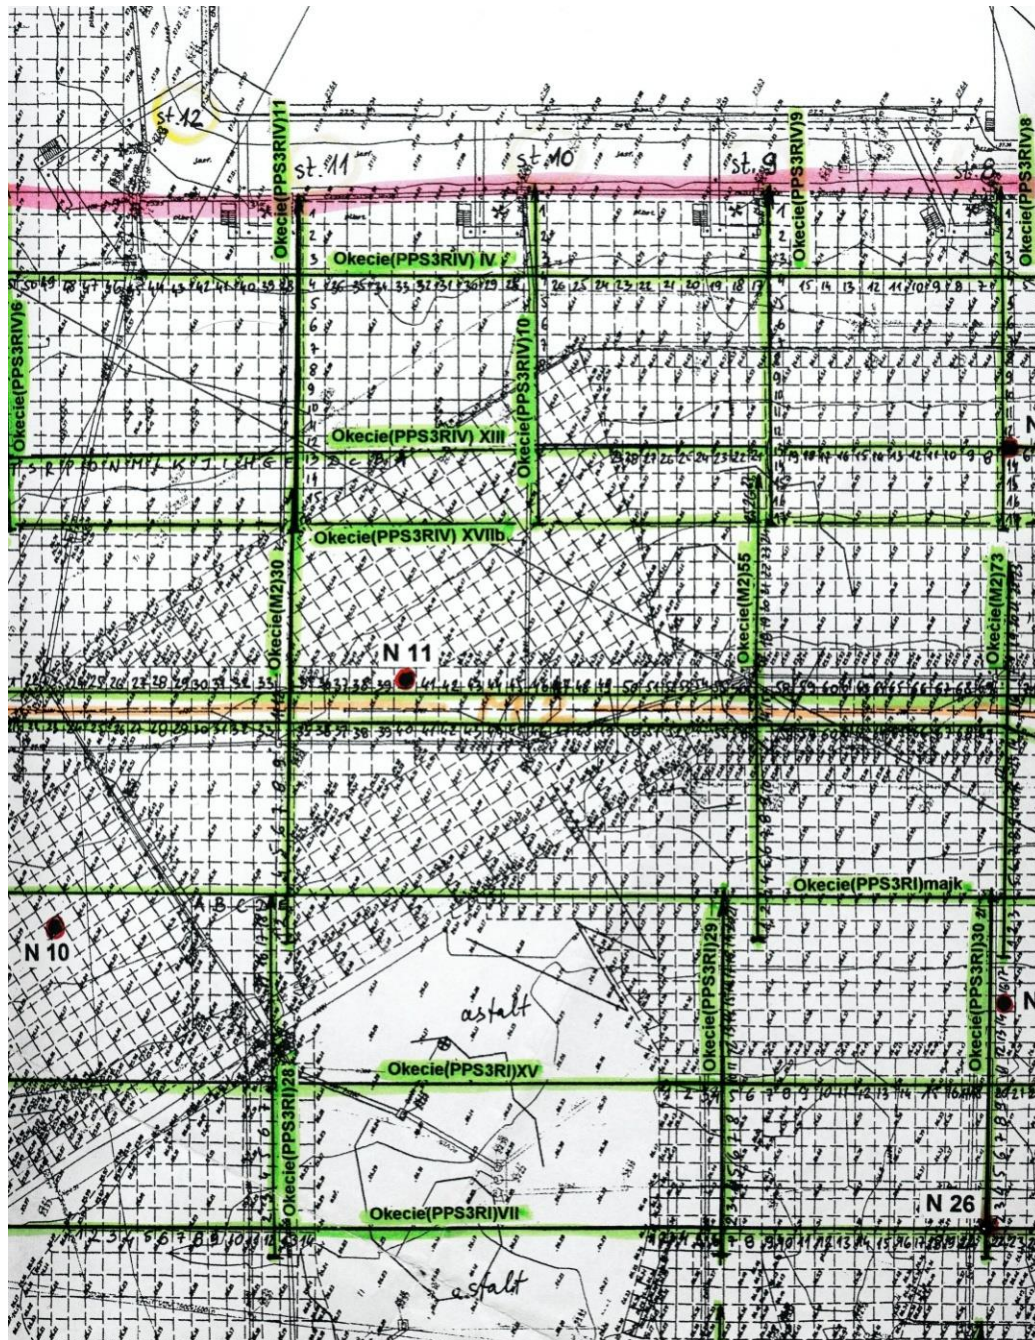
4. Location of selected GPR cross-section lines (green line) and selected pavement drillings

GPR profiling was conducted on selected lines. During two weeks of work, two operators completed a total of 30 km of cross-sectional lines. The geological interpretation of the GPR data was made on the basis of drilling data. GPR models of the airport pavement were developed:

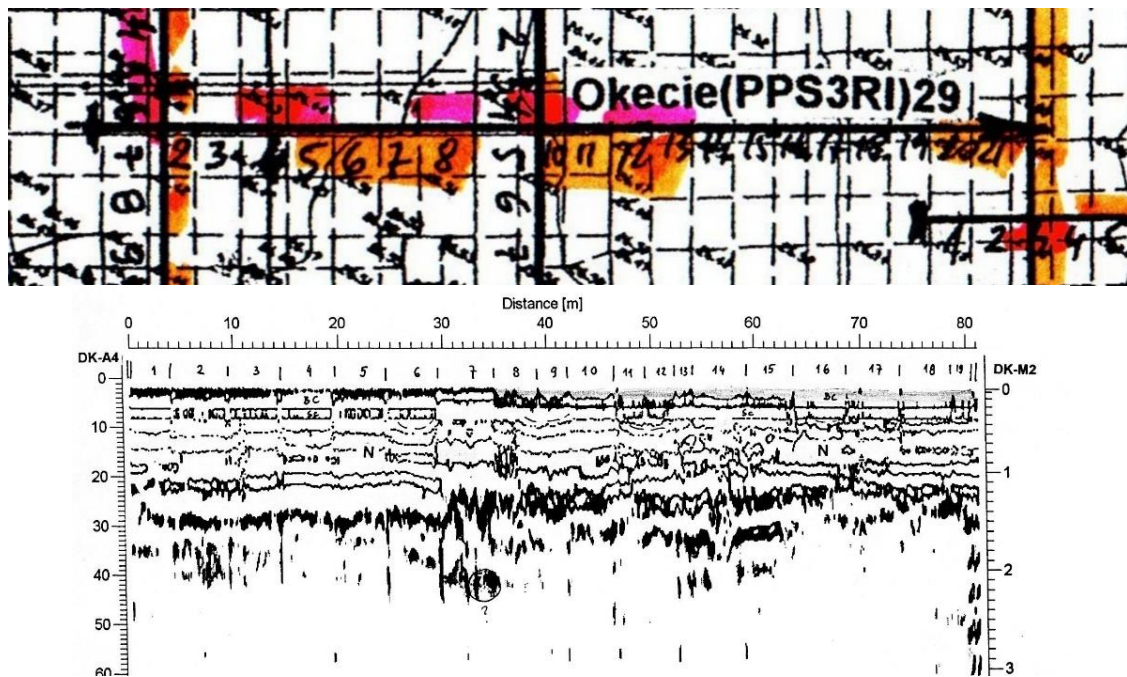
11. GPR (PPS3RI) 29 section , from DK-A4 to DK-M2.

The plates are numbered, and their condition is marked on the map (at the top): good - white plate (e.g. 3), cracked and pressed (e.g. 6), bad condition (e.g. 8, 12).

On the map showing the airport pavement, the test results for each plate are marked on the GPR section line (Figures 11, 12).

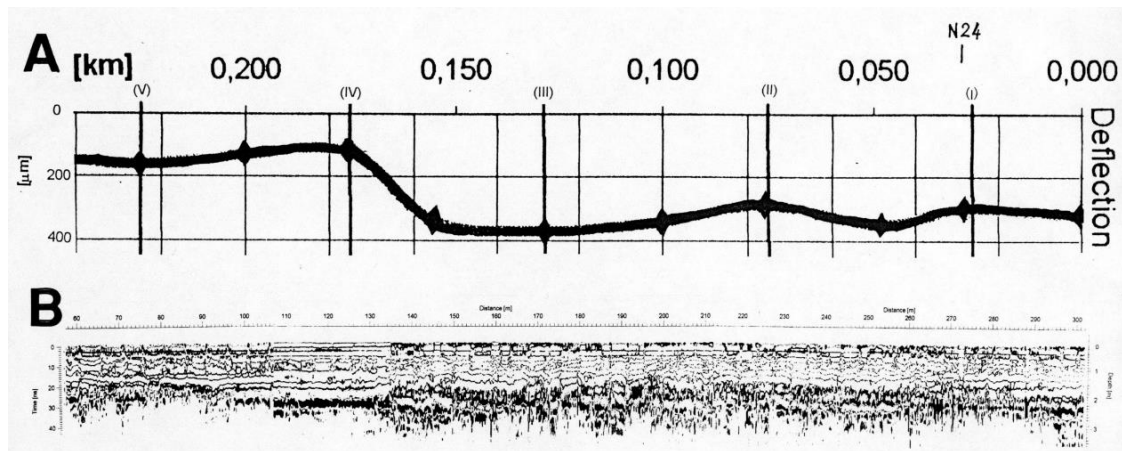
13. Comparison of the results of the HWD (A) tests and the results of the GPR (B) tests on the same cross-sectional section (I-V - control points)

The comparison shows the convergence of the research results. From 0.000 - 0.170 km, HWD shows that the plates are in very bad condition (cracked). Comparable section GPR (135-300 m) also shows that the plates are in very bad condition, but the picture of each plate is more accurate..

The results of each GPR cross-sectional line were compared with the results of the HWD tests carried out by the Airport Construction Department of the Military Institute of Aviation Technology in Warsaw (example in Figure 13).
