Mariusz Wesolowski

Instytut Techniczny Wojsk Lotniczych

Stabilization of the subsoil and leveling of concrete paving slabs

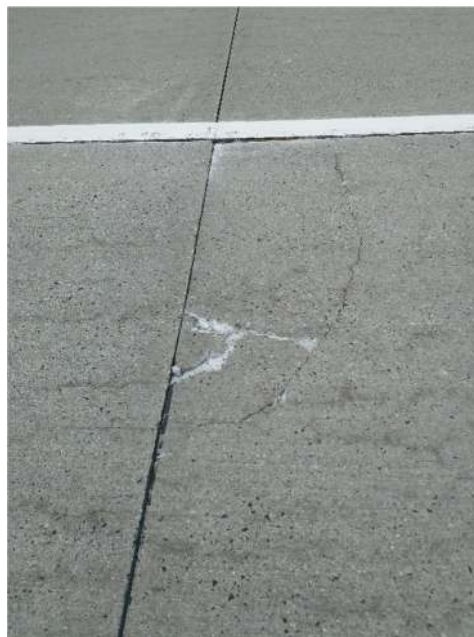
1. Plate edge breakage as a result of subsidence

Concrete pavements are extremely practical and economical, provided that we know how to handle them during operation and how to eliminate the causes of any damage. Generally, we divide damage into two types: structural and superficial. Structural damage, which is evidence of the durability of the pavement structure, primarily cracks in the boards originating on the surface or in the bottom of the layers, deformation of the joints, subsidence (keying) of the boards [5, 6, 7]. Surface damage, i.e. the durability of the driving layer, is abrasion of the surface, surface flaking (shallow and deep), hairline and mesh cracks, frost cracks, and edge damage to the boards. On the other hand, point damage consists of craters (small air voids), orange chippings, deep cavities, and broken corners of concrete slabs [4, 8]. For example, plate edge fracture as a result of subsidence is shown in Figure 1.

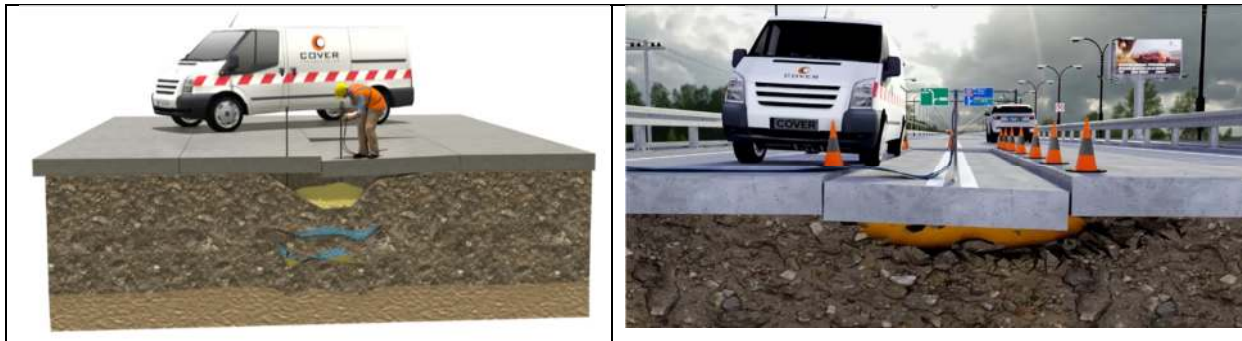
2. The use of geotechnical injection to lift the slab in the concrete pavement

The use of intelligent, two-component, fast-acting materials based on resins eliminates the need to demolish the building, injection works are performed in a non-invasive way, consisting in drilling perpendicular holes with a diameter of no more than 14 mm through the surface plates (Figure 2). Accurate selection of the parameters of the injection should be preceded by tests and in some cases a trial section in order to identify the situation and clarify the parameters of the injection material in terms of foamability (foamable - expansive, non-foaming, low-expansive), viscosity (viscous, low-viscous), absorbency due to the existing state and type of substrate.

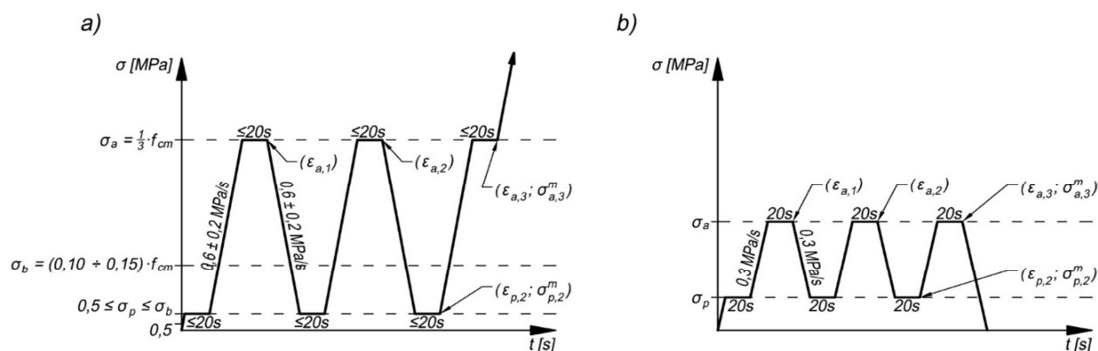
3. The test diagram of the modulus of elasticity: a) according to PN-EN12390-13: 2014-02, method B; b) modified method

Initially, tests of the elasticity modulus of two materials used in the low-pressure injection technology were carried out under laboratory conditions at the Airport Department of the Air Force Institute of Technology in order to select one of them for use in field studies. The test specimens were made of two-component materials: Cover Geolift 2K and Cover Geopur 2K, used in the filling and pushing injection technology. The stabilized incisal modulus of elasticity was determined by method B according to PN-EN 12390-13: 2014-02 [11], empirically modified (Figure 3).

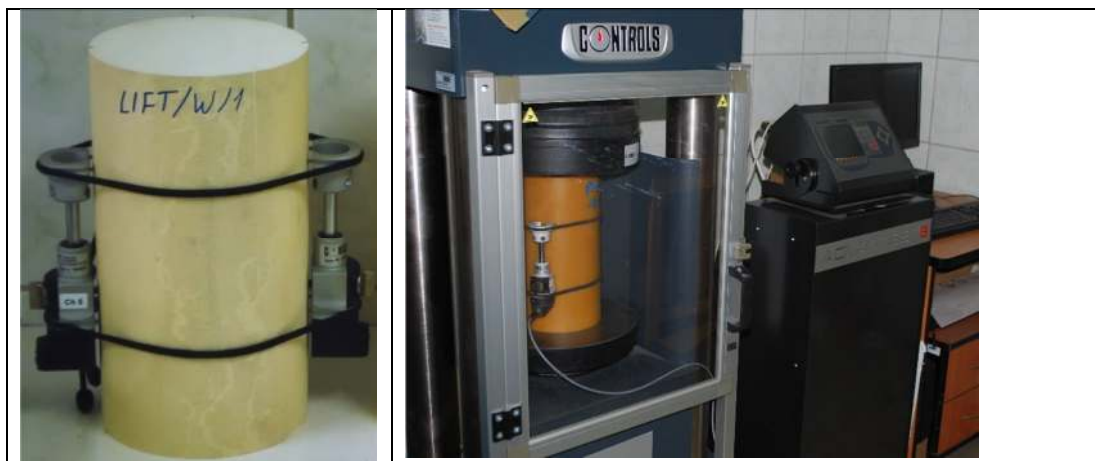
The tests were performed with the use of a testing machine for static tests, type 50-C9842 by Controls, and 3 deformation sensors type 55-C0222 / G by Controls with a set measuring base L0 = 120 mm and a measuring range of 118.5 ÷ 121.5 mm (Figure 4).

4. Testing the modulus of elasticity of a sample of material for geotechnical injection, a) a sample of Cover Geolift 2K material prepared for testing b) a view of a sample of Cover Geopur 2K in a testing machine

The test results are presented in the Table 1. Finally, the Cover Geolift 2K material was selected for fieldwork, for which the average value of the stabilized secant modulus of elasticity was 680 MPa.

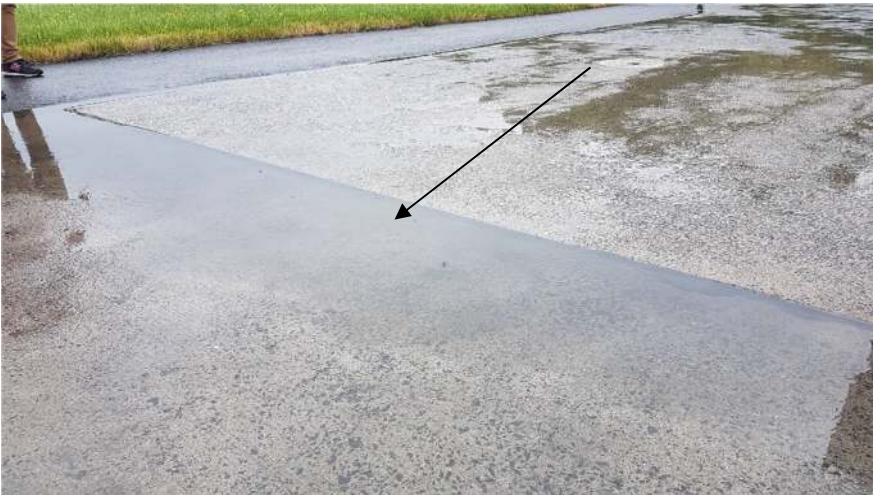
5. View of the plate edge lowering at the parking stand (flooded with water) - slot marked no.2

The view of the pendulous plates is shown in Figure 5. After the tested pavement was cleaned with an airfield cleaner, injection holes were drilled (Figure 6) in accordance with the marked grid, in which steel injection lances were embedded (Figure 7), and then low-pressure injections were carried out, controlling during construction displacement works (Figure 8).

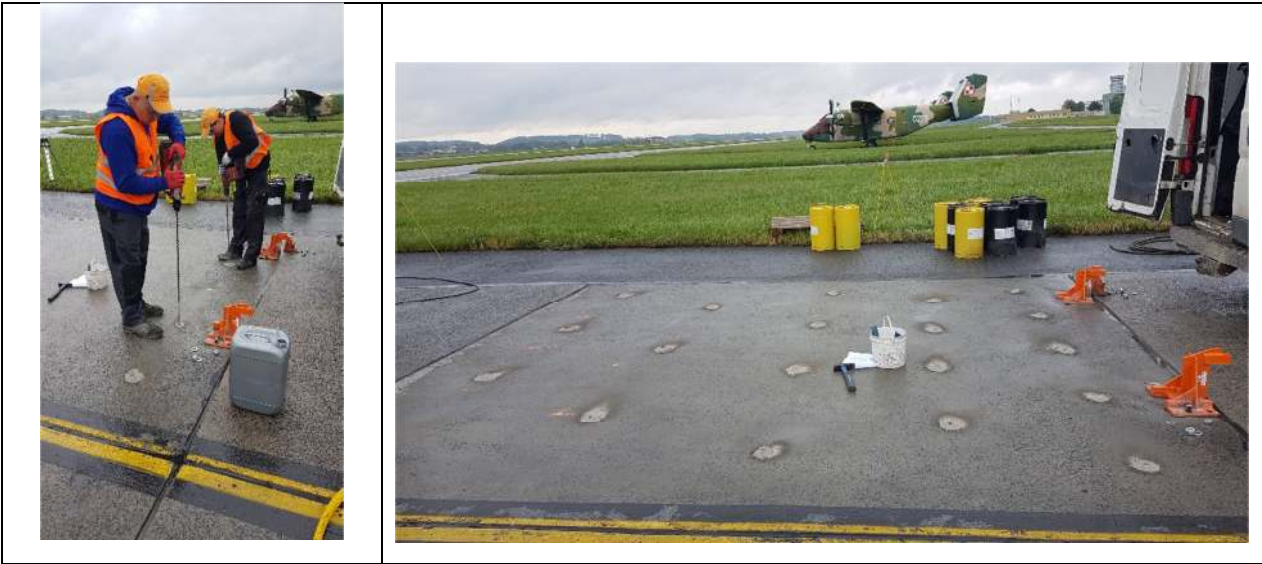
6. Drilling injection holes with a diameter of 14-16 mm (according to the marked grid)

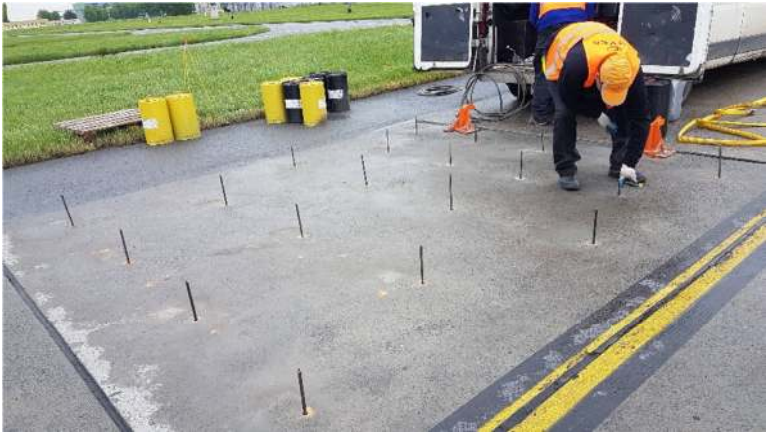
7. Embedding in drilled holes, steel injection lances

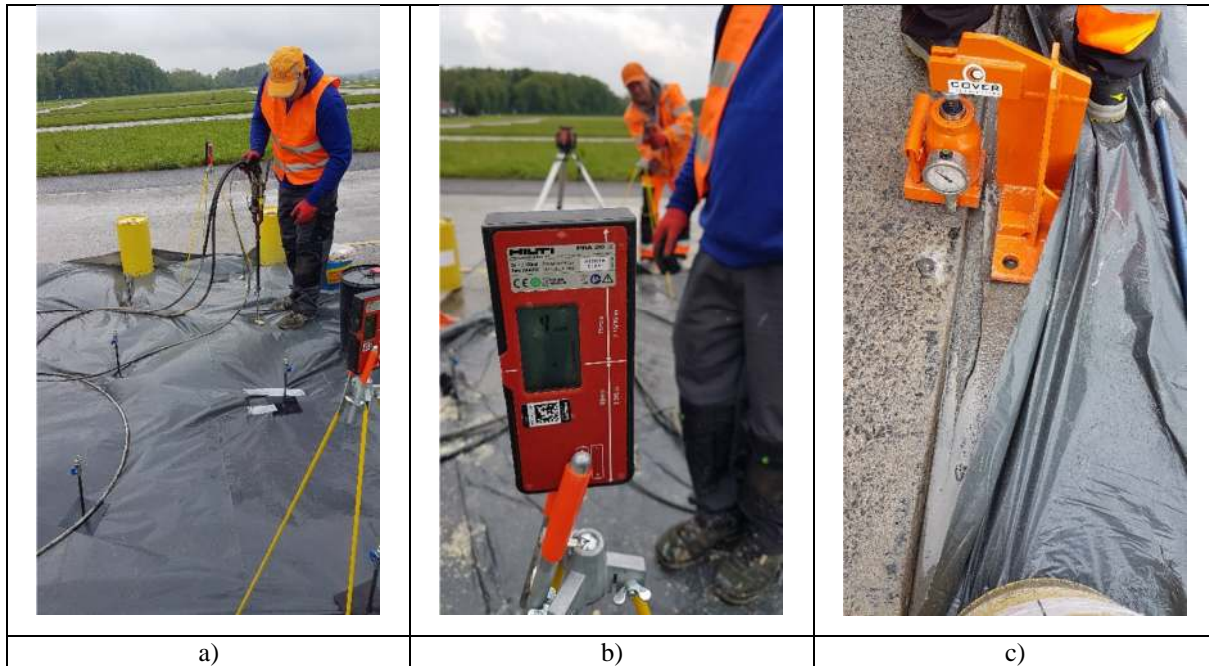
8. Performing a low-pressure injection of the foil-protected plate (a). Controlling displacements of structures during injection works (b, c)

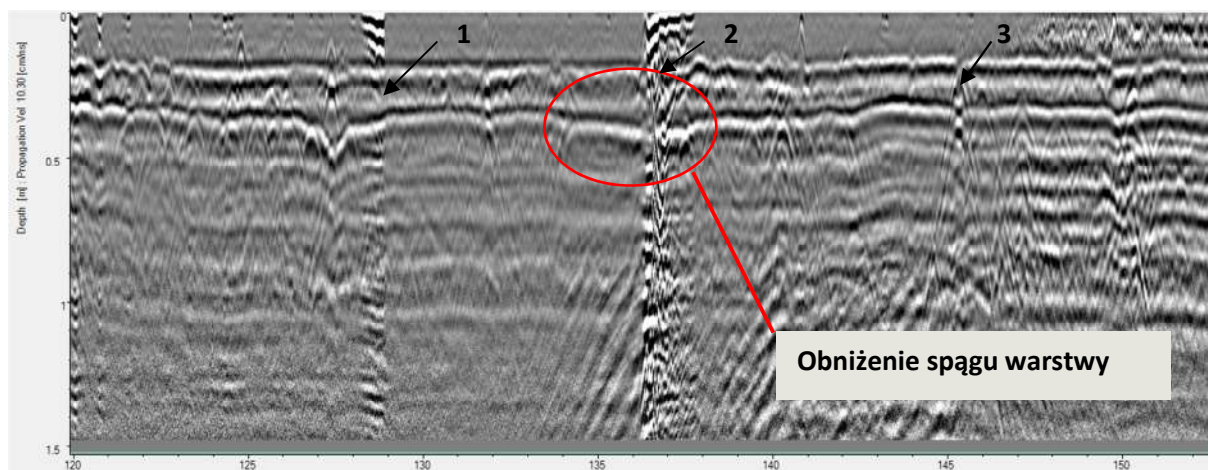
9. Echogram showing the longitudinal profile (including 4 plates) obtained as a result of GPR measurement before injection. Expansion gaps are marked with numbers

The visible expansion gaps between the boards are marked with numbers on the individual profiles. The existing undercutting of the floor of the layer located directly under the structure of the lifted slab allows us to believe that there has been a reduction in the degree of soil compaction in this area, compared to the ground in the immediate vicinity. Most likely, this phenomenon resulted in the displacement of the concrete slab. GPR tests performed after the injection procedure showed changes in the subsoil located directly under the slab structure. The echograms showed an area showing different characteristics compared to the subsoil. In connection with the performed procedures, it should be assumed that this is the injected material. Much of the material was introduced under the plate immediately adjacent to the lift plate.

The GPR research was performed using the RIS MF HI-MOD # 1 GPR system from the Italian company IDS, equipped with a dual-frequency antenna with a range of 600-2000 MHz. During the measurements, due to the presence of moisture on the surface of the element and locally occurring puddles, the depth range of the GPR was about 1.0 m below sea level. Figure 9 shows a characteristic profile for the analyzed area before injection, and Figure 10 - a characteristic profile after injection.

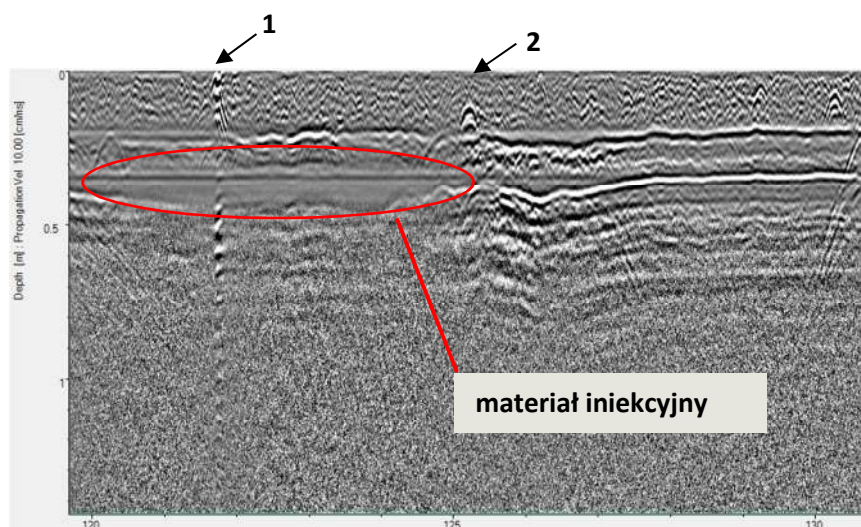
10. Echogram showing the longitudinal profile obtained as a result of the measurement after the injection

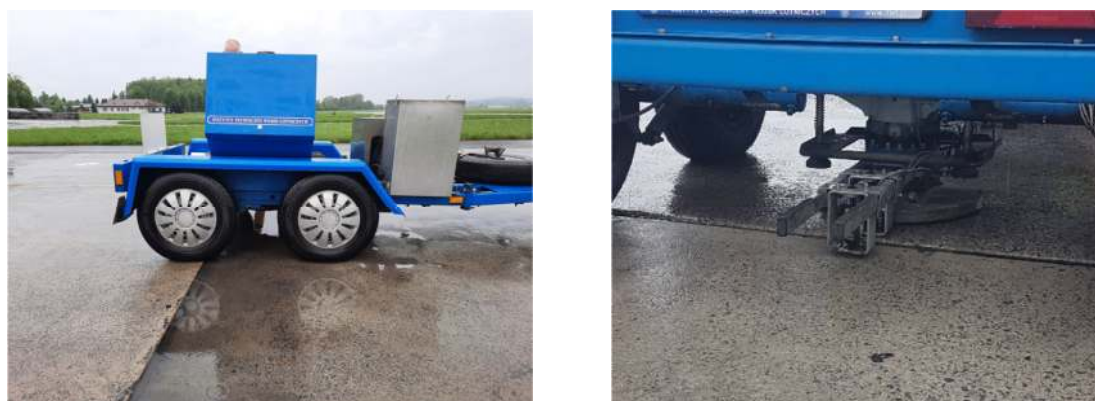
11. HWD impact deflector during measurements of elastic deflections

The test was carried out by measuring the elastic deflections at the edges of adjacent concrete slabs of the assessed airport pavement with a plate with a diameter of 450 mm, with a force transmitted to the pavement of about 200 kN. The results of testing the cooperation of concrete slabs before and after the injection are presented in the Table 2.

The cooperation of adjacent concrete slabs embedded in the pavement of the studied area was tested with the use of a Heavy Weight Deflectometer (HWD). Figure 11 shows the HWD impact deflection meter during the measurements of elastic deflections of the pavement of the tested section at the connection of concrete slabs.

On the basis of the obtained test results, it can be concluded that the cooperation between the boards before injection was limited and the average value of the load transfer coefficient was 66.1%. After the injection, the average value of the load transfer coefficient was 83.4%, which means good cooperation of the plates. Considering the above, it should be stated that the tested technology improves the cooperation of the plates when transferring the load. The results of the elastic deflection measurements show that the performed injection contributed to the increase of elastic deflections of the pavement (1075.4 μm) by 34.3% compared to the state before the procedure (800.8 μm). The average value of the calculated equivalent modulus of the pavement structure after injection (515.1 MPa) decreased by 25.4% compared to the reference state (690.6 MPa).
