**Piotr Mackiewicz**

**Eryk Mączka**

**Drone usage for pavement damage identification**

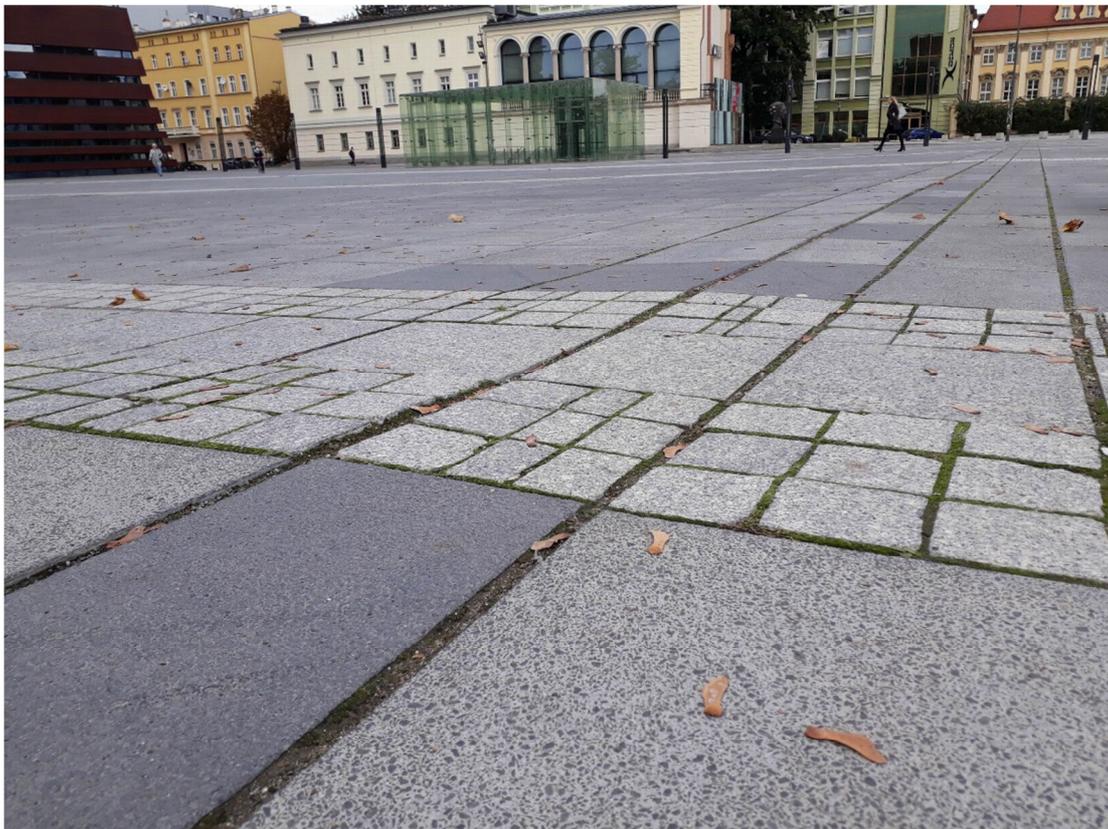
1. A fragment of the analyzed square

The joints are filled with cement mortar to a depth of min. 4 cm, and the width of most joints is from 2 to 8 mm. The general view of the pavement is shown in Figure 1.

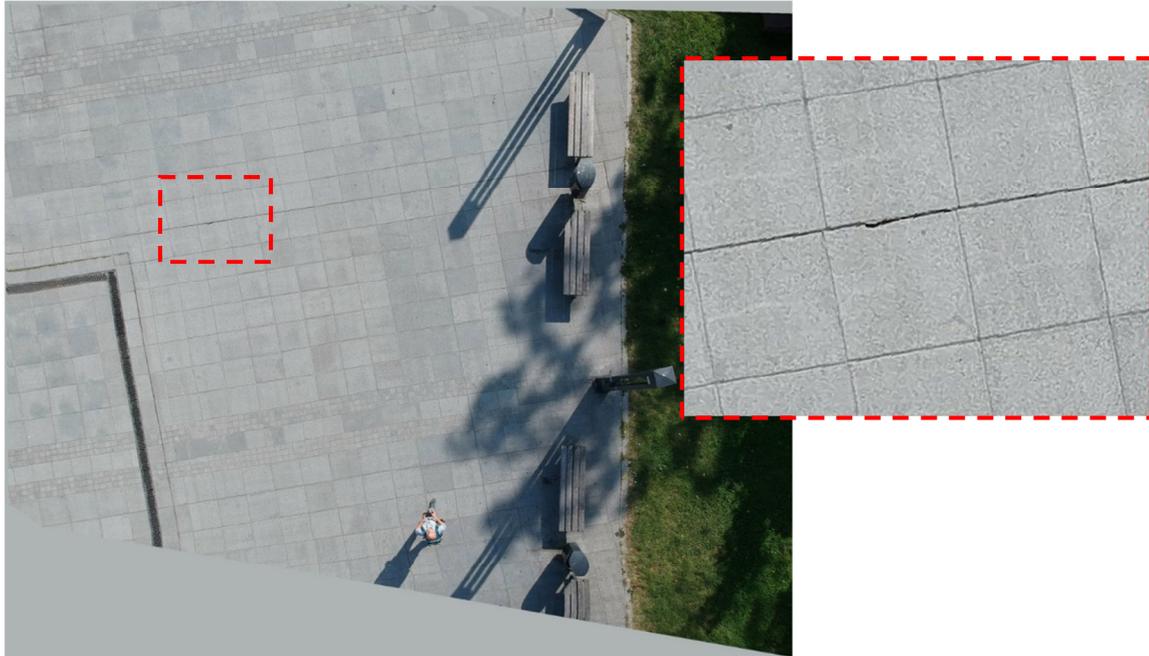
3. Sample photos taken by the drone

In order to identify the damage to the square in detail, a series of photos was taken using the DJI SPARK drone (Figure 3).

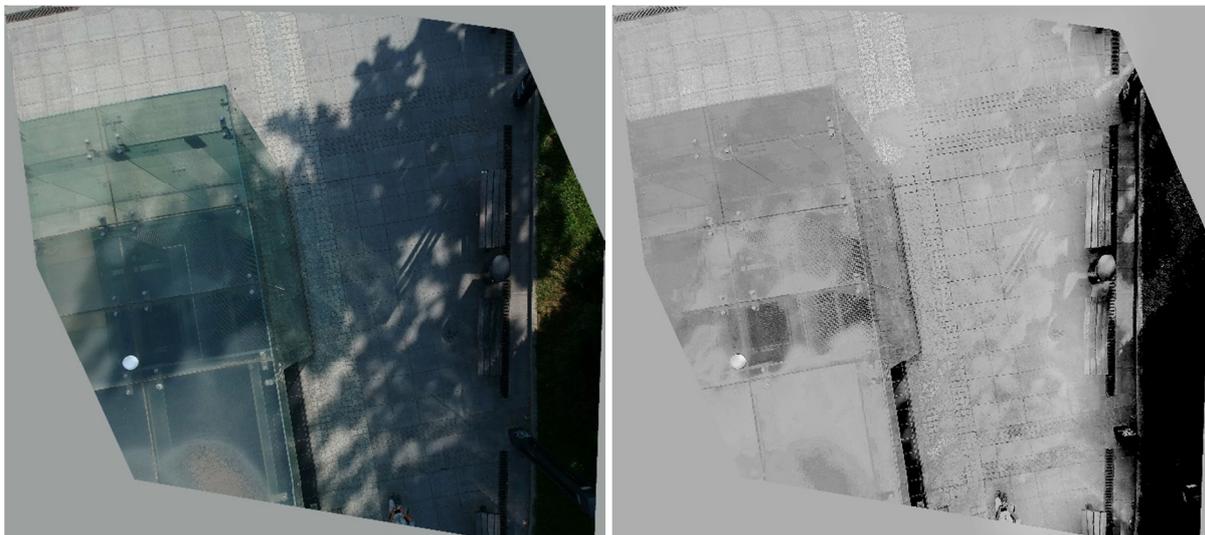
4. Sample photos of image correction due to area shading

The registration of the area was recorded in the form of photos with a resolution of 12 Mpixels, taking into account the "overlap" of photos, which was useful in the next stage of calibration and combining photos. About 400 photos were recorded for the analyzed square. During the inventory, there were good weather conditions, little wind, and no precipitation. In some areas, there were shadows from trees and objects, which required additional graphic processing of images at a later stage (Figure 4).

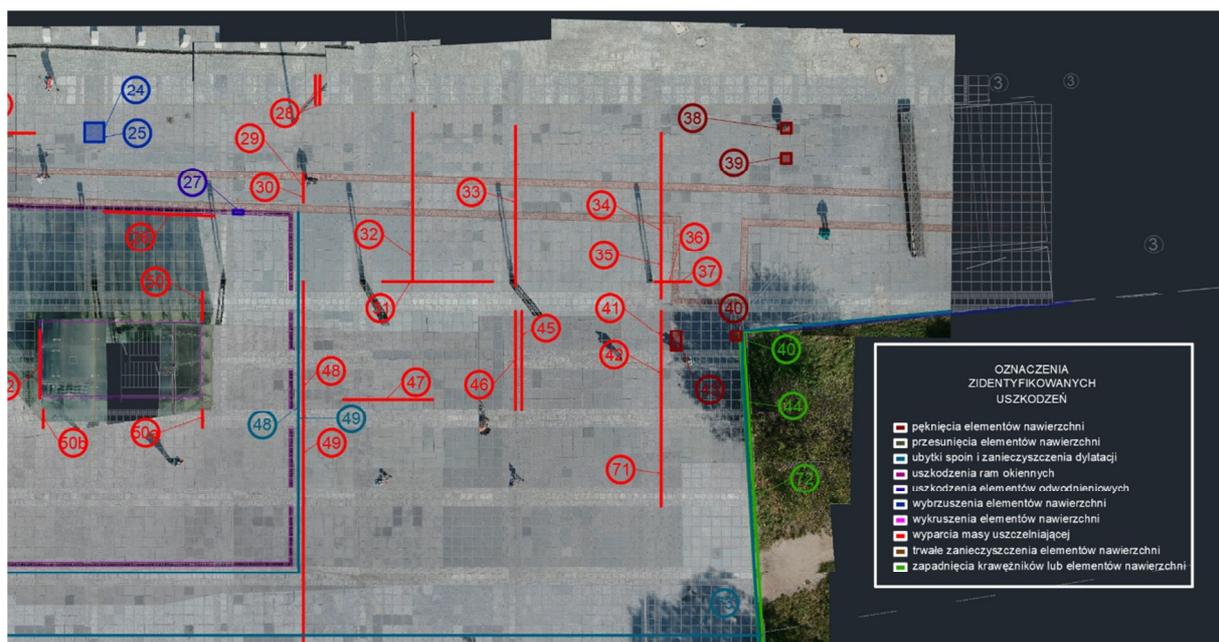
8. An example of the output of a damaged object's calibrated map

It should be noted that to create a map of the real state without deformation, the original images must be calibrated and properly cropped, which is allowed by the Raster Design extension. When recording images with the drone, each area partially overlapped. After calibration, overlapping image fragments were cropped. In this way, a coherent area without visible discontinuities was obtained (Figure 8).
