**Evaluation of regenerative capabilities of piezoelectric fuel injectors**

**Abstract:** The article presents the issue of regeneration of injectors with a piezoelectric actuator, taking into account existing limitations and the availability of original spare parts. The scope of required maintenance activities by leading fuel equipment manufacturers was compared, as well as the types of diagnostic tests conducted in separate laboratory facilities. Examples of measuring devices that should be standard and optional equipment in workshops operating in this service sector were provided. Through our own research, it was demonstrated that this process can be effectively carried out, even when there is a need to expand existing production procedures. Improving the efficiency of these repairs aligns with environmentally friendly practices, as extending the product lifecycle is in line with the concept of sustainable development. Furthermore, the technology that replaces first and second-generation electromagnetic injectors is supported, and its application has a direct impact on increasing fuel dosage precision, achieving faster response to changing driving conditions, as well as enhanci

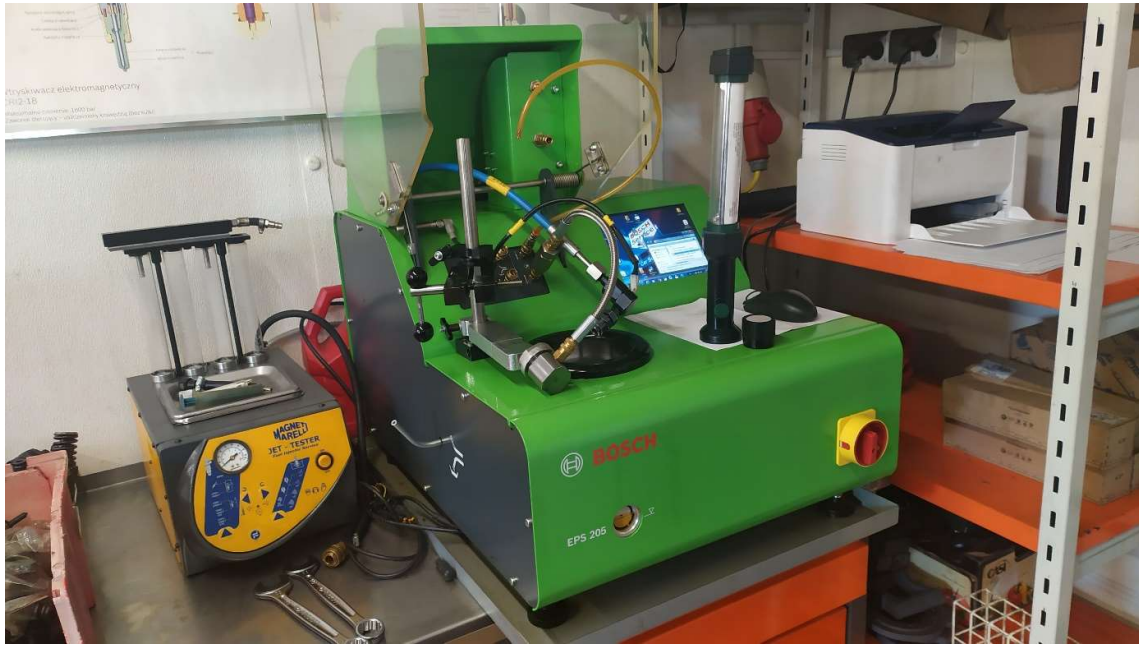
2. Compact test bench EPS 205 (Bosch)

All examinations of fuel systems that require the disassembly of their executive components from the engine are classified as invasive methods. Among these methods, the most precise and reliable way to control the technical condition of injectors is through tests conducted on specially dedicated test benches. These are universal station devices equipped with single or multiple measurement circuit systems. They are available in compact versions (Figure 2), as well as modular constructions (Figure 3), allowing for the installation of additional equipment in line with the workshop's profile and capabilities. The benches are equipped with necessary adapters and connections for the installation of hydraulic and electrical lines to the injector. This enables not only comprehensive testing but also internal cleaning, which involves a thermochemical flushing process with high-pressure and elevated temperature detergent.

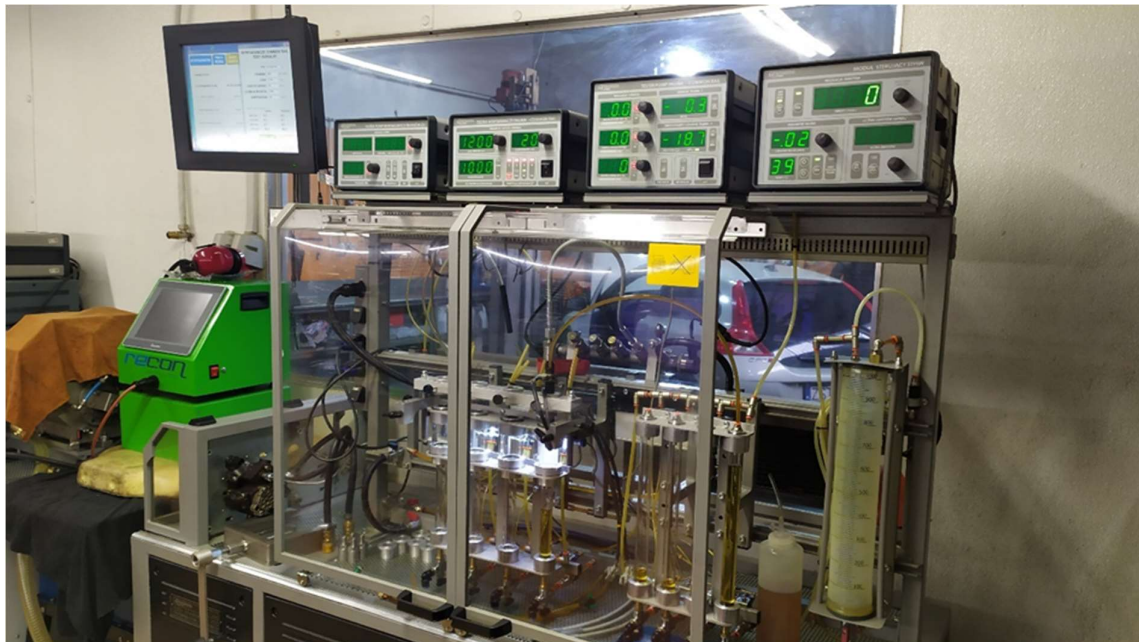
3. Modular test station STPIW-3 (Autoelektronika Kędzia)

The technical condition is assessed based on approved procedures, including electrical, leak, nozzle opening pressure tests, etc. Any deviations detected in these tests immediately result in the discontinuation of the initial testing phase. In the case of positive results, flow measurements are conducted at various activation times and operating pressures. Typically, these measurements are performed in automatic cycles or less frequently with manual adjustments, where the quantity of individual doses and corresponding return flows are checked at several operating points, thus simulating changing engine load conditions. The results are

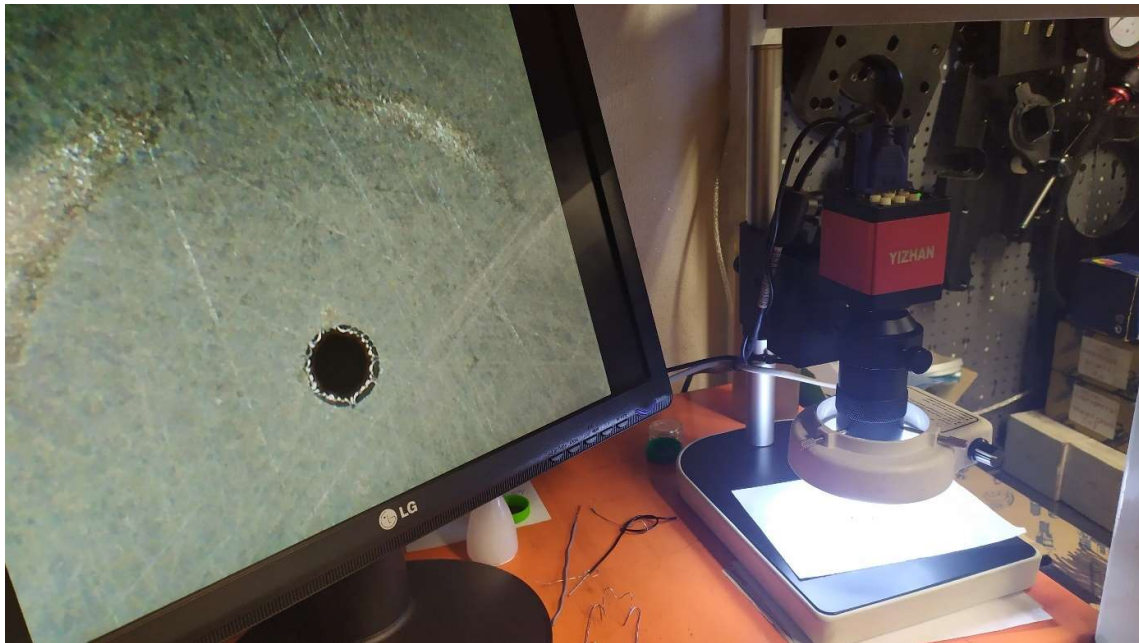
4. Microscopic inspection using Yizhan 13MP HDMI VGA industrial camera  
*Source: own study*

Examinations under high magnification aim to determine the degree of wear and detect any potential malfunctions in the components that are part of the executive and control assemblies. These examinations are carried out on separate laboratory stations equipped with an optical stereoscopic microscope capable of digital image recording or an industrial camera (Figure 4). In standard procedures, it is assumed that visual inspections precede the stages of cleaning individual components in ultrasonic cleaners and their thorough drying with compressed air. However, this sequence may change in situations where there is a reasonable suspicion of the presence of metal filings that enter the fuel system from a faulty fuel pump.

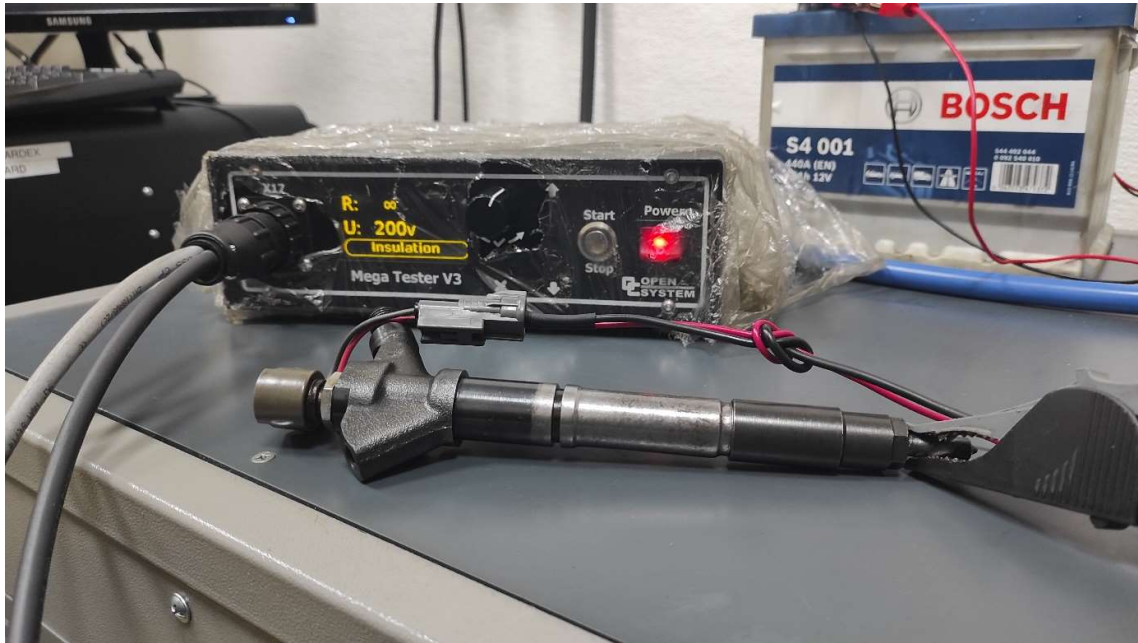
5. Electrical measurements of Denso G2P injector on Mega Tester V3 probe  
*Source: own study*

Another group comprises optional testing equipment that assists the fundamental diagnostic process. In the case of piezoelectric injectors, probes are extremely useful as they enable expanded measurements of the actuator and precise determination of its technical condition (Figure 5). Another example is leak testers, which are useful for detecting leaks within the overflow pipe and nozzle (Figure 6). By applying a control pulse from an additional device, it is also possible to assess fuel atomization quality, nozzle opening time, etc.

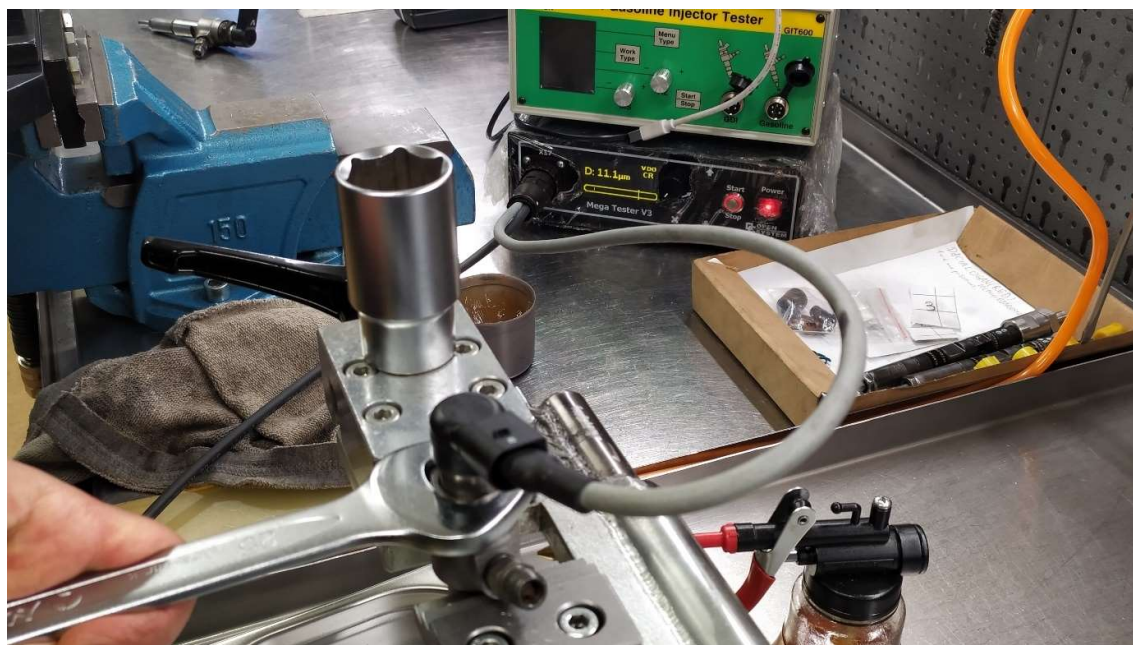
7. Adjustment of the air gap (GAP) in Siemens VDO Continental injectors

Table 1 presents a comparison of diagnostic and service procedures carried out in the process of regeneration of piezoelectric injectors. It can be observed that the procedures of individual manufacturers are similar to each other and differ in a few aspects. First and foremost, Siemens VDO Continental products require the adjustment of the air gap, referred to as GAP, located between the actuator and the hydraulic transducer (Figure 7). This is due to their specific construction, as the stack of crystals is not placed inside the main body but is attached to it using

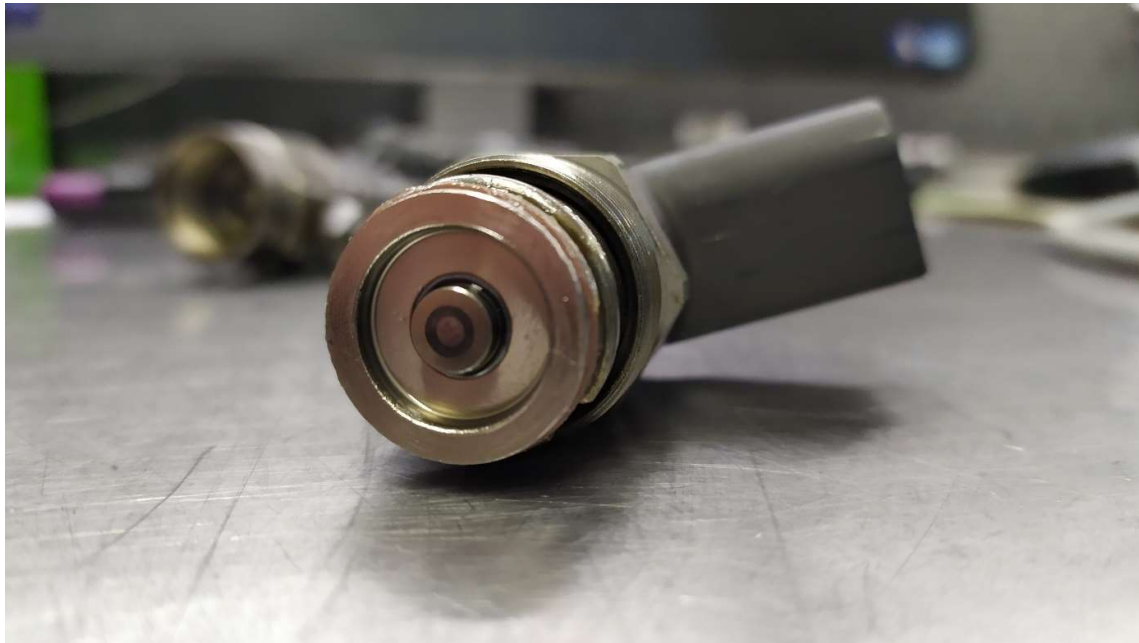
8. Disassembled injector actuator 2.3 PCR from Siemens VDO Continental

Unfortunately, access to specialized equipment and dedicated tools does not always translate into the effectiveness of the regeneration process. The main problem is the lack of spare parts (Table 2). Firstly, most manufacturers do not offer the replacement of the piezoelectric stack, which is why the technology behind this process has not been made available. An exception to this is the substitutes for Siemens VDO Continental injectors, which can be obtained in the primary market. Such actuators are referred to as solenoids, as their disassembly method is analogous to electromagnetically controlled constructions (Figure 8). Secondly, the remaining executive components are completely disassemblable, allowing for thorough cleaning in ultrasonic baths and microscopic inspections. However, identifying damage outside of the nozzle (needle and atomizer) becomes problematic in the case of Denso and Delphi products. In individual cases, used parts can be used, which come from injectors previously deemed irreparable, usually due to crystal damage. These parts are often left by customers themselves or obtained through other means, such as from collaborating auto repair shops, purchased online in the secondary market, etc. However, this process, referred to in the literature as cannibalization, is difficult to consider as a comprehensive solution when considering the actual scale of demand for regeneration services.

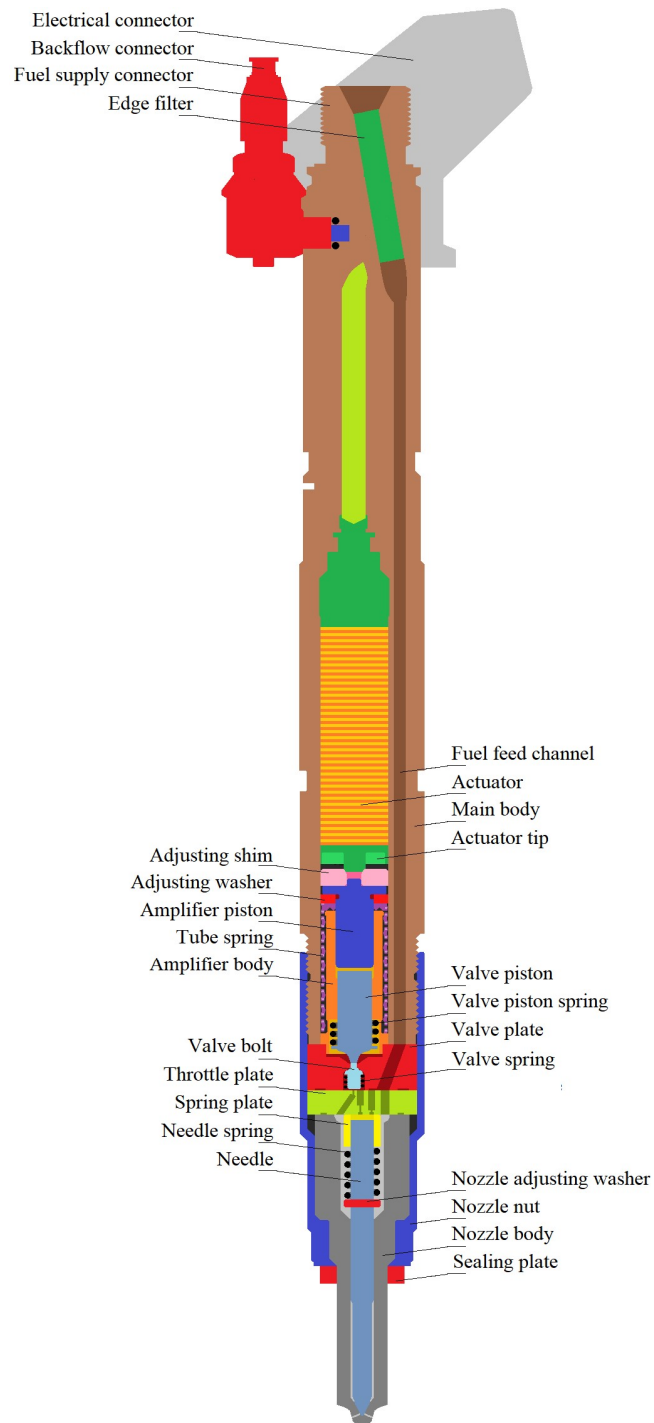
**9. Bosch CRI3-16 fuel injector design**

Based on years of laboratory-workshop practice, it is evident that even the availability of spare parts may prove insufficient for a successful regeneration process. Prolonged usage leads to a decrease in the initial extension of the stack and its impact on the actuating components. This is due to the degradation of crystal properties resulting from the aging process [6, 14, 15]. As an example, our own study involved the Bosch CRI3-16 injector, which was disassembled from a 2.0 dCi Nissan X-Trail engine with a mileage of 322,000 km. Figure 9 illustrates its internal structure, highlighting the key control and actuating elements.

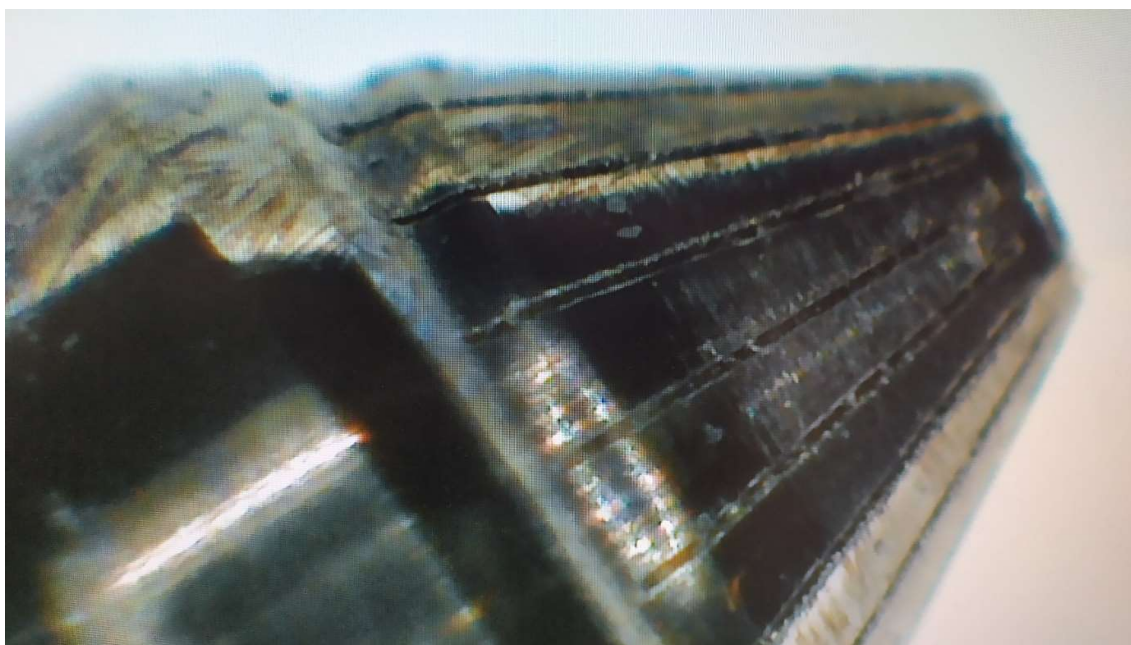
**10.** Example of corrosion and needle wear  
*Source: own study*

Electrical tests ruled out permanent failure of the piezoelectric actuator, as its resistance and capacitance fell within the manufacturer's specified ranges. However, preliminary flow tests revealed an incorrect value of the full-load dose VL (Table 3). Therefore, a decision was made to disassemble the components for detailed microscopic inspections. Corrosion was observed on most fuel-contacting elements, and traces of abrasive wear were identified on selected working surfaces (Figure 10). As a result, the complete nozzle assembly, valve, and hydraulic transducer were replaced.

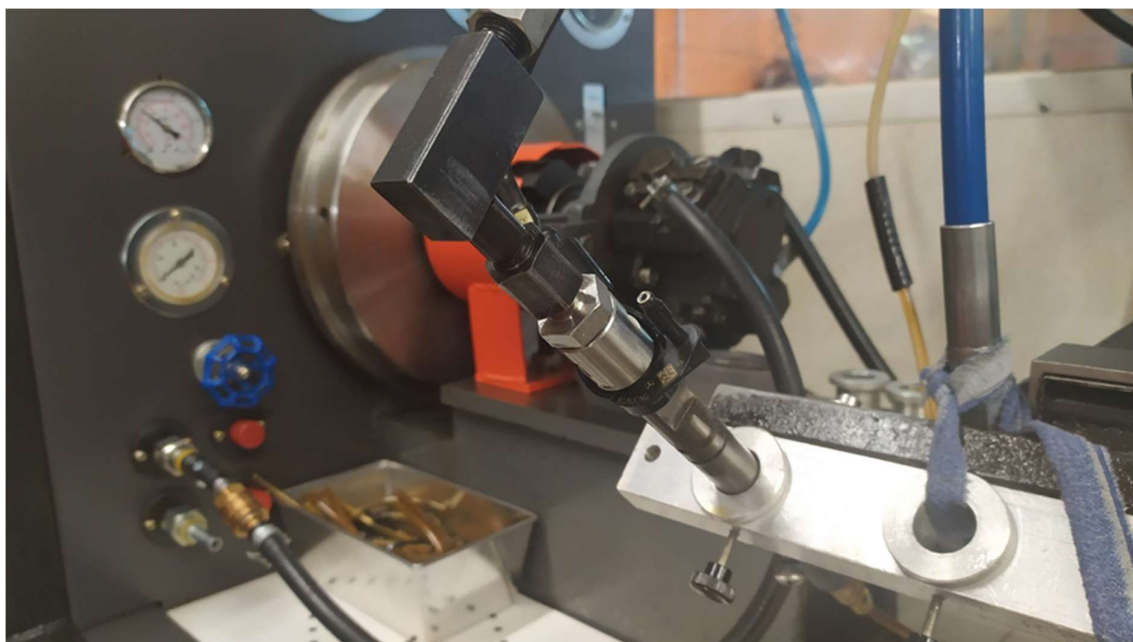
11. Testing of the Bosch CRI3-16 injector on the 12PSB test bench with the Stardex set  
*Source: own study*

The performed actions proved to be insufficient as the fuel delivery was still not correct. It was decided that intervention in the hydraulic converter would be necessary to ensure the required length compensation. In the absence of support from the manufacturer, who does not provide repair technology or specific selection group shims, the surface of the front face of the element was ground down by 0.25 mm. From the data presented in Table 4, it can be concluded that the regeneration of the tested injector was successful, as the main flow tests yielded results within the nominal ranges (Figure 11). Furthermore, the applied adjustment method had an impact on increasing the values of all fuel doses, not just at the intended operating point. In this regard, the decision to replace the valve group is also significant, as the sealing integrity of the valve group was compromised during the long-term operation of the injector.
